FLORIDA SOLAR

Energy Efficient Renovations of Storm Damaged Residences - Florida Case Studies

FSEC-CR-1648-06

September 8, 2006

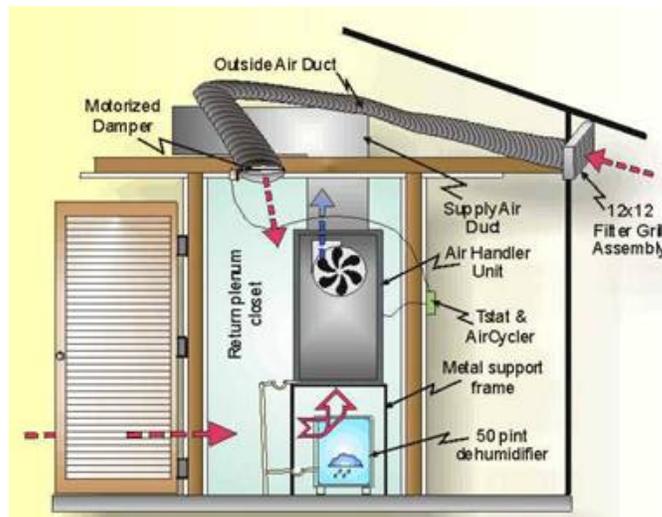
Figure 2 Dehumidified Return Plenum w/AirCycler Control

The use of the unvented attic which reduced the Air Changes Per Hour at 50 pascals (ACH50) from 10 down to 6 has caused the homeowner to consider adding mechanical ventilation for better perceived indoor air quality. The owner has also been considering the addition of supplemental dehumidification for enhanced comfort. Spot ventilation is present via bath fans, windows, and exterior vented kitchen range hood to remove intermittent sources of humidity, but it is rarely used. The owner has purchased equipment and installed necessary ductwork to implement the mechanical ventilation / supplemental dehumidification scheme shown in the following figure, but has not yet made the scheme operational.

Table 8 Home A Mechanical Ventilation / Supplemental Dehumidification Costs

50 pint per day dehumidifier	180
6” flex duct – 25 feet	41
10” x 10” ductboard box	12
10” x 10” filter back grill w/pleated filter	21
6” duct collar with manual damper	8
<i>homeowner purchased</i>	Total
	\$ 262

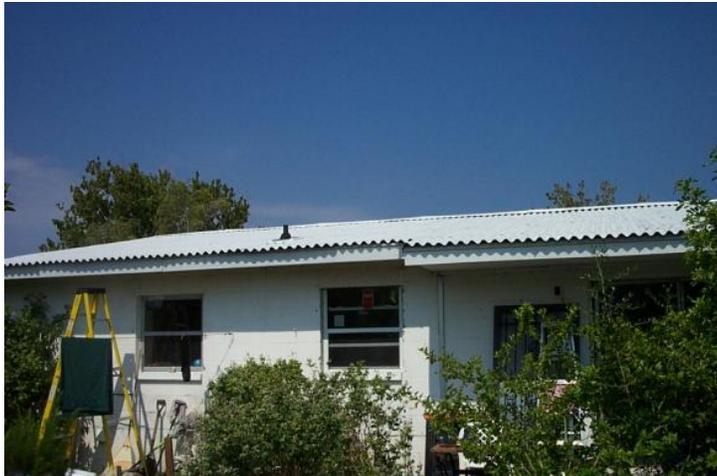
Figure 5 Finished light colored composite roof panels installed

This home was the most severely damaged of the four buildings in the analysis. A section of the rear portion of the roof was destroyed allowing water to enter into the dwelling which resulted in severe damage to the interior. As a result, the interior had to be completely demolished and rebuilt per recommendations. This retrofit included

Table 16 Home D Contractor Installed Roofing Costs

Remove existing roof	<i>Price not broken down</i>
Apply synthetic underlayment	
Apply batten system	
Install drip edge, flashings, boots, kitchen vent and ridge cap	
Install light fiberglass composite panel roof	
Total (approximate)	\$ 15,000

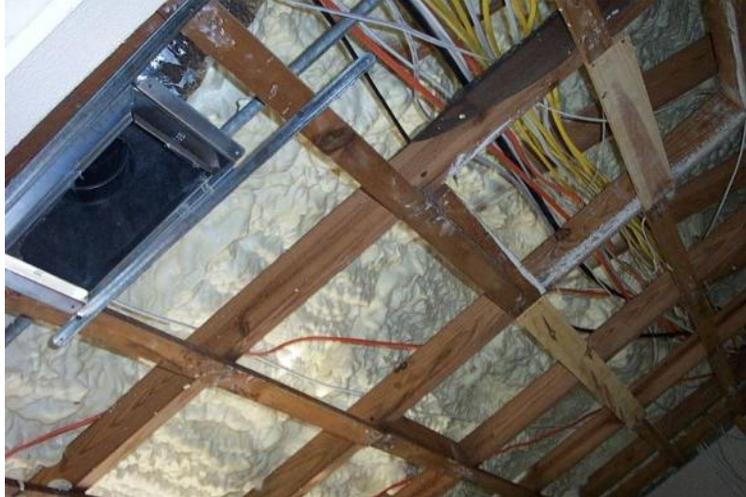
Figure 6 Sealed attic with spray foam insulation (Icynene™). Note the duct work is below the insulation, which places it within the air & thermal boundaries.

Table 17 Home D Contractor Installed Insulation Costs

5 ½ inches (R-22) Icynene™ foam under pitched roof (~\$2/sqft)	\$3180
Total	\$ NC
Material and labor costs were donated by Icynene to research post retrofit energy consumption
