Final Report of Task 8 ARRA: Energy Code Compliance and Effectiveness Measurement Project

FSEC-CR-1922-12

June 15, 2012

Florida Department of Business and Professional Regulation
(Formerly Florida Department of Community Affairs)

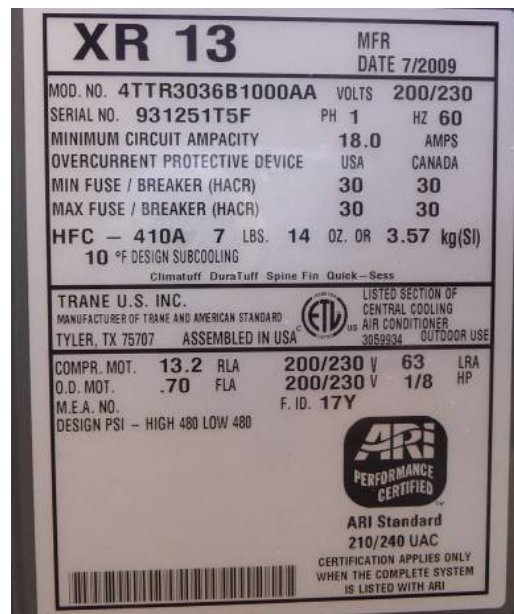
Figure 8. Photo of condensing unit tag, with model number listed at top of this 35.0 kbtu cooling system.

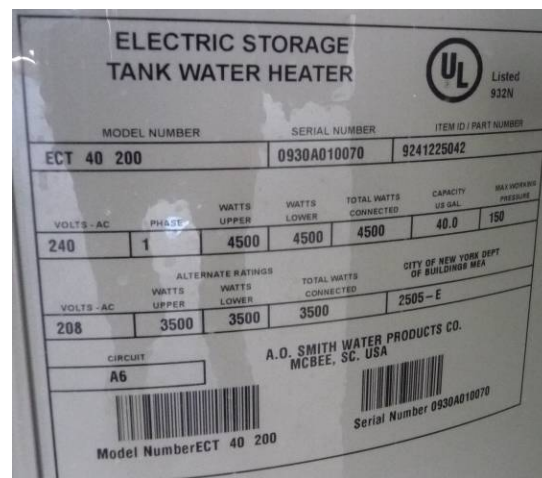
Electric and gas hot water system energy compliance are evaluated by the efficiency factor (EF). Figure 11 shows model number data taken from an electric domestic hot water (DHW) tank that is used to look up the efficiency rating using AHRI. Figure 12 shows the AHRI certificate stating the 40 gallon electric water heater has an EF=0.92.

Figure 11. Photo taken of the 40 gallon electric storage domestic hot water heater nameplate. The model number and manufacturer are looked up using the AHRI rating directory to determine the efficiency. The rating certificate is shown below.
