Investigating Solutions to Wind Washing Issues in Two-Story Florida Homes, Phase 2

FSEC-CR-2041-15

Final Report April 2015

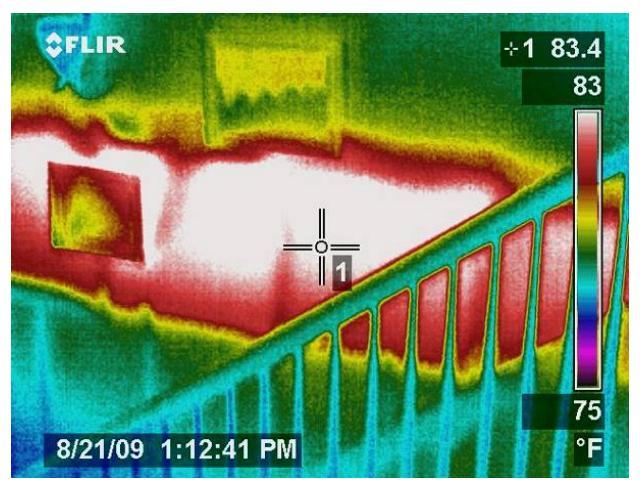
Figure 17. Summer IR image shows where hot attic air has penetrated into the floor cavity that lies behind the stairwell wall. The wall surface temperature at the floor cavity interface was 83°F compared to 77°–78°F room air temperature.

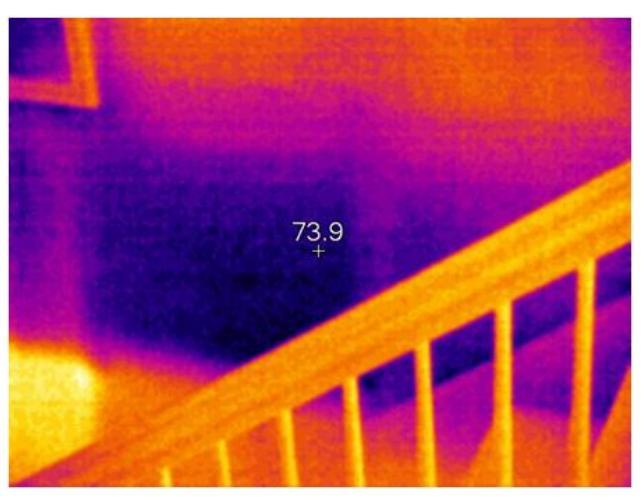
Figure 18. Winter IR image shows where cold outdoor air has penetrated into the floor cavity that lies behind the stairwell wall. The wall surface temperature at the floor cavity interface was 73.9°F, about 1.5°F colder than the room air temperature. Overnight low outdoor temperature was about 44°F several hours prior to the image with calm wind conditions.

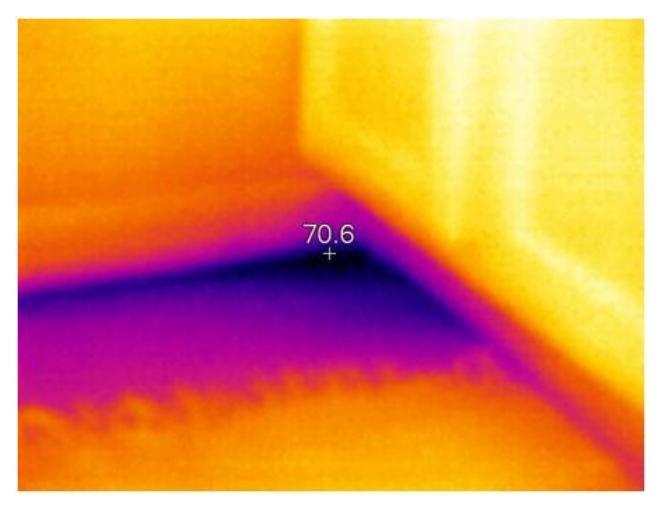
Figure 20. A bathroom floor had relatively cold surface temperatures compared to the heated area around it because of wind washing in the floor cavities below the floor.

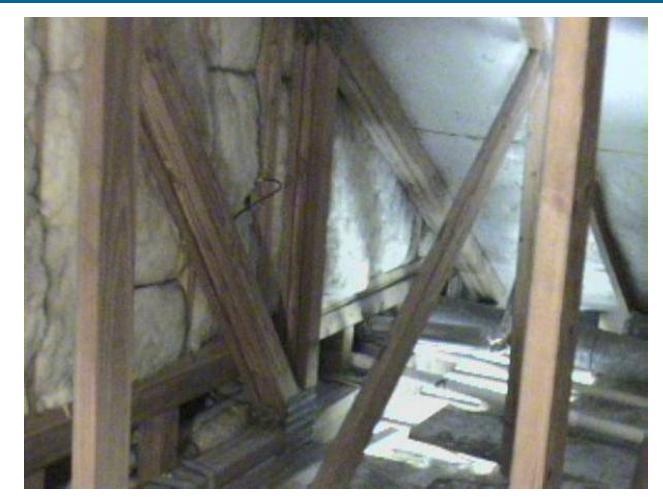
Figure 34. Floor cavity opening and knee wall can be seen in House H16B prior to foam insulation application.

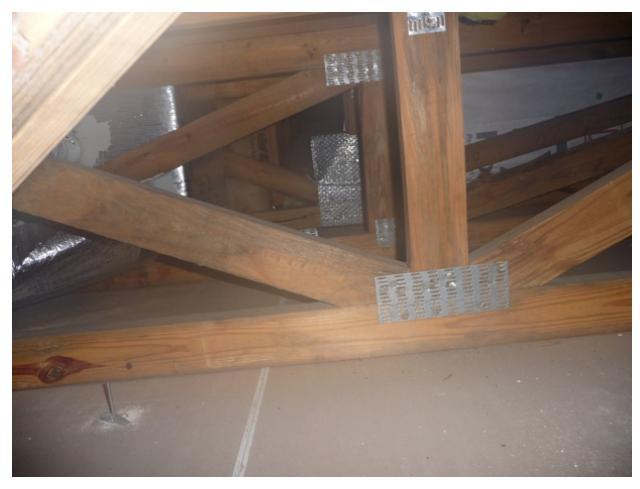
Figure A3. Looking from east attic space into open floor cavity (view toward the west)

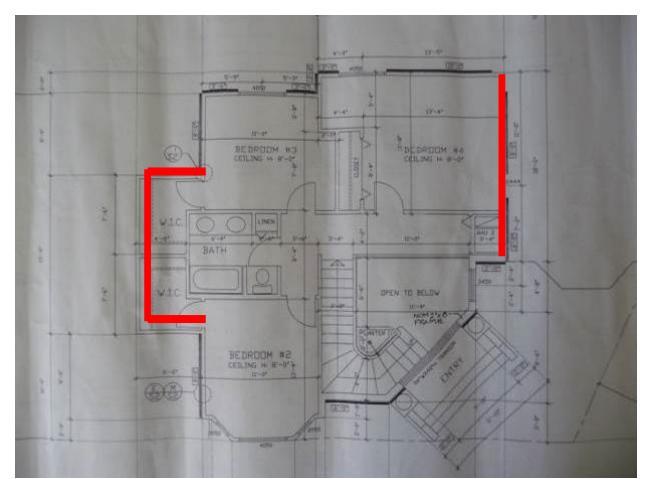
Figure A10. Second-story floor plan. Red lines indicate areas of openings from attics into floor cavities.

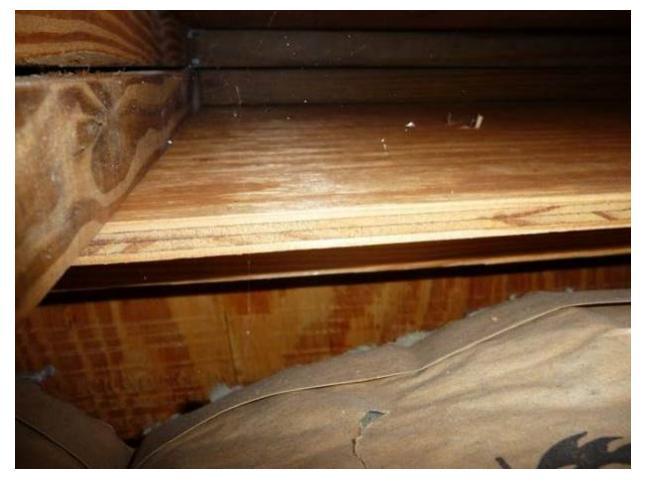
Figure A11. View looking up into a vacant wall cavity from within the east attic shows no insulation in this wall next to a walk-in closet.

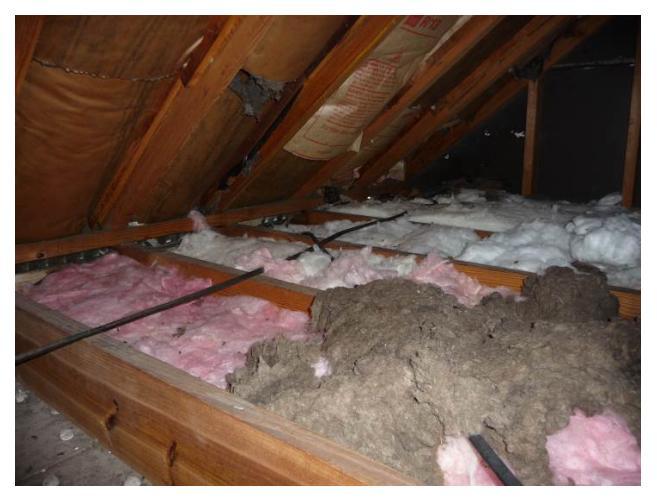
Figure A16. Pieces of old batt insulation, which have fallen from the roof deck above, can be seen in one area on the attic floor.

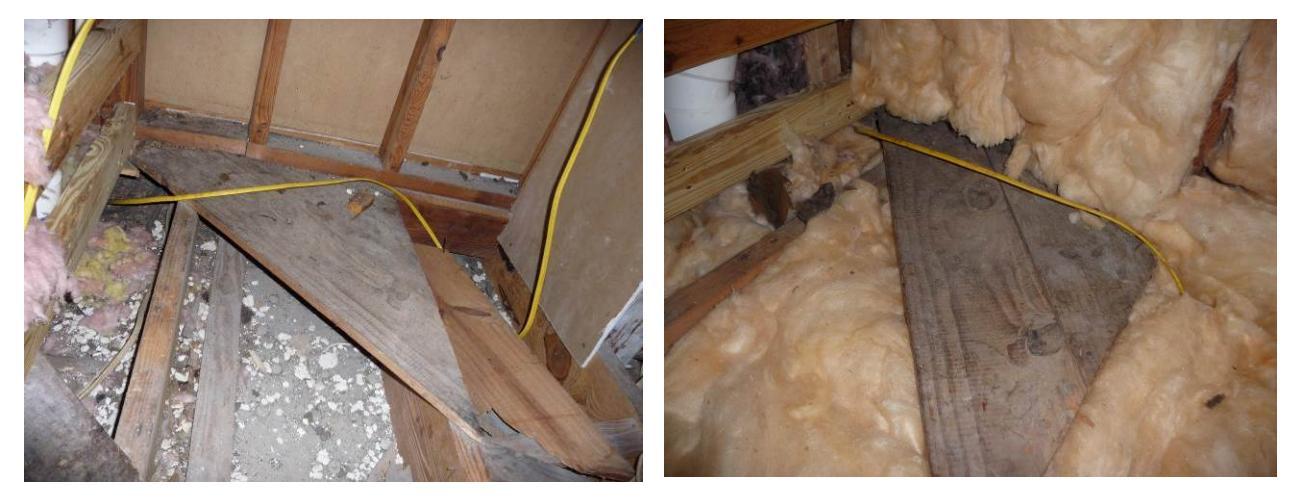
Figure A18. A section of unsealed and uninsulated floor cavity and knee wall in left photo and during repair with R-30 kraft-faced batt insulation installed in photo on the right.

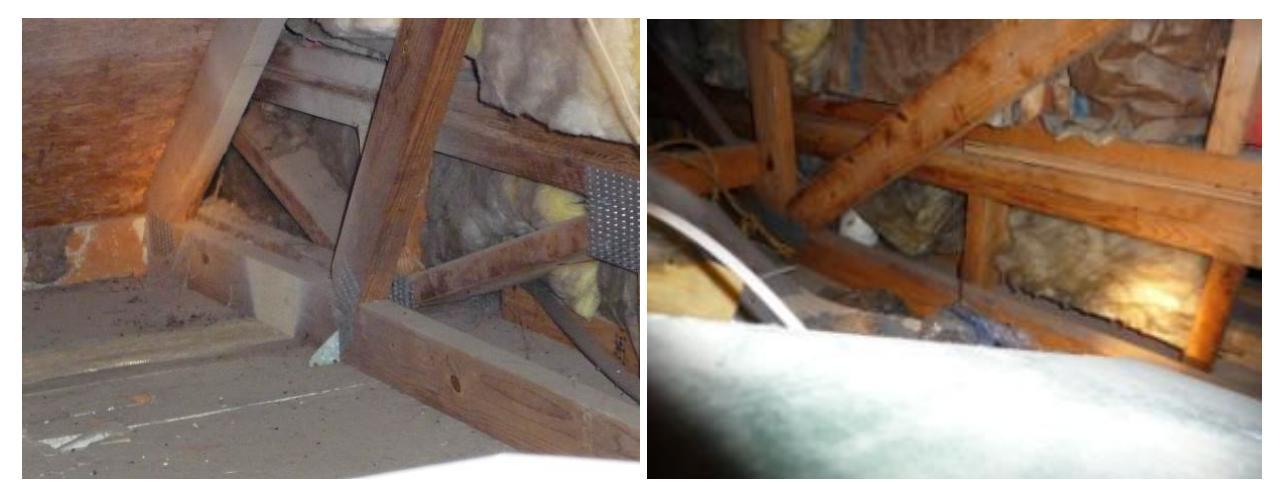
Figure A21. At left is a floor cavity section where existing batts do not seal the space. At right is another section with compressions and voids in the batt.

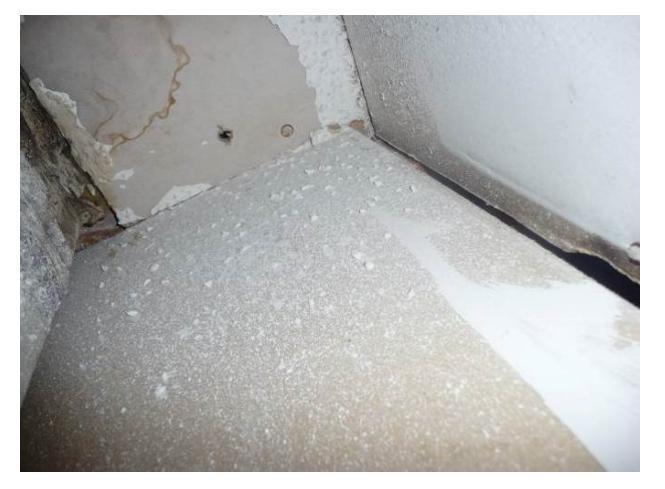
Figure A23. View of AHU closet ceiling. The closet, which operates at negative pressure because it is a return plenum, is very leaky to the second-story floor cavity as a result of unfinished drywall wall at the corner and large gaps in the ceiling. Some areas of air leakage were identified by squeezing a digital camera into tight areas between the AHU and the wall.

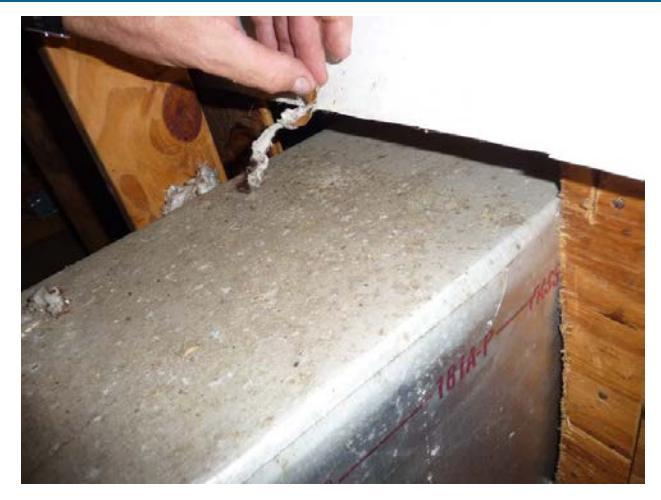
Figure A26. Air flows from floor cavity into west attic area pushing paper away from floor cavity leak toward the attic space. This leak is a complementary pathway to larger floor cavity leakage in the east attic.

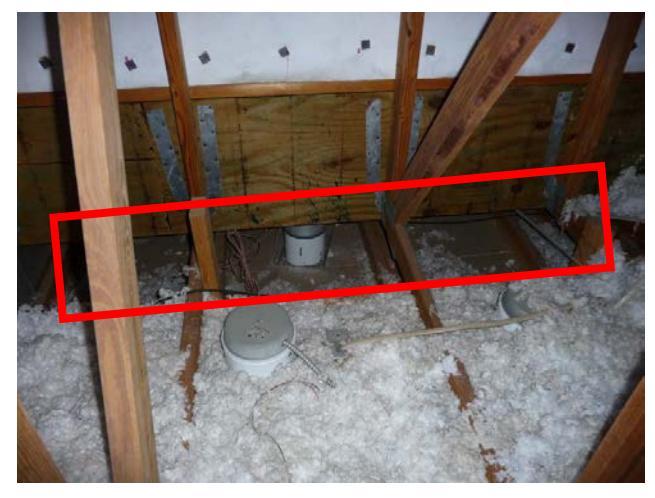
Figure A27. View of pathway from the garage (east) attic into a floor cavity, which results primarily from a dropped ceiling over the kitchen.

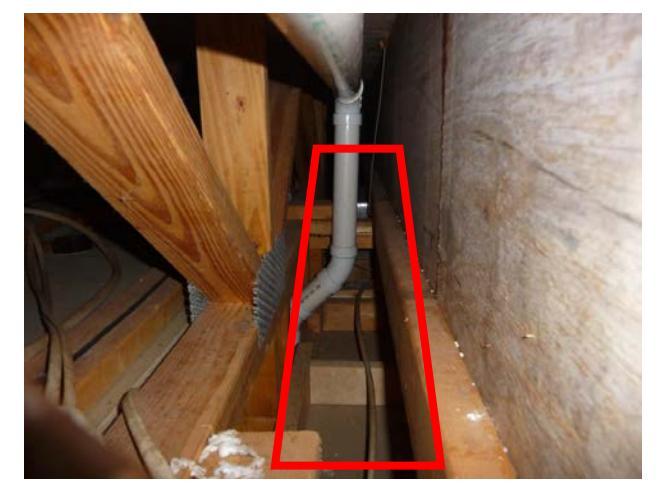
Figure A30. View of the inside floor cavity at corner leak in preceding figure. A large area of the floor cavity is effectively covered by well-placed plywood, but air circumvents this from under the dropped ceiling area at the red box.

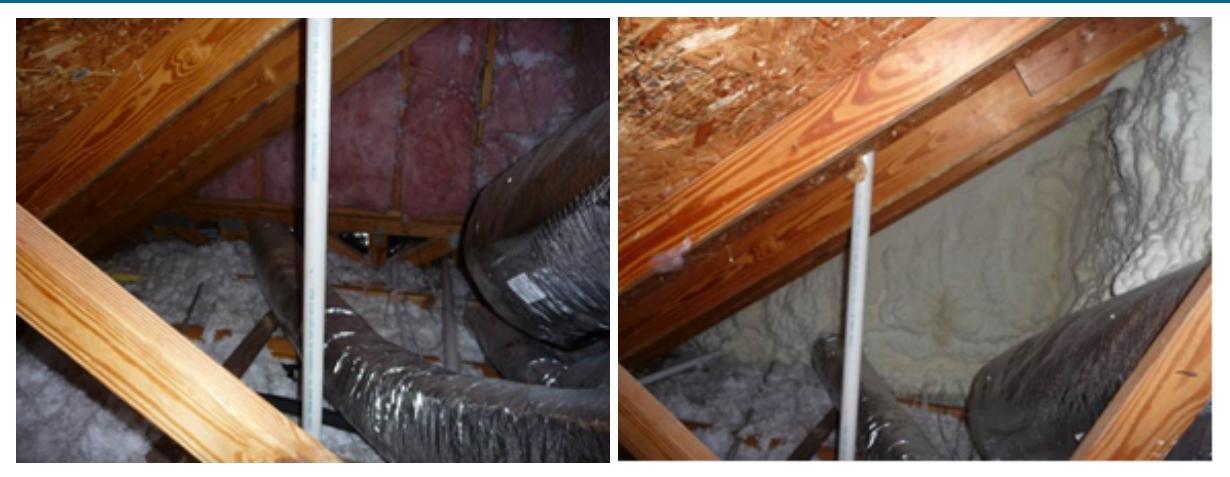
Figure A35. East side of floor cavity and knee wall before and after repair

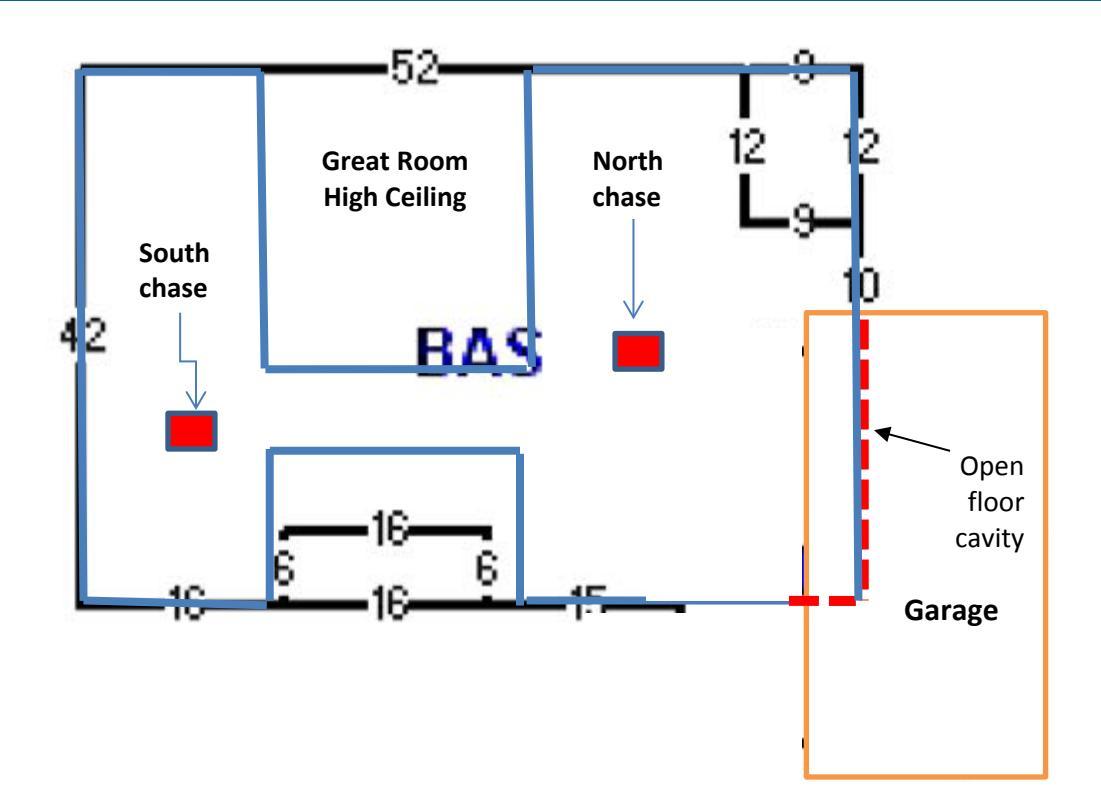
Figure A37. Floor plan layout of House H47W showing leakage areas at red dashed line and red boxes. The floor plan overlay of the second-floor area is outlined in blue lines.

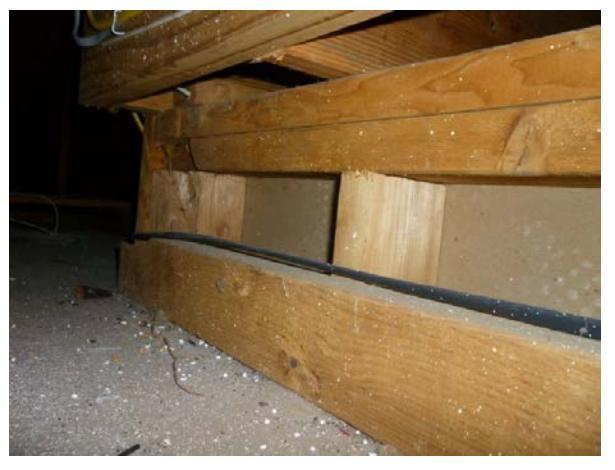
Figure A38. Second floor has a cantilever section inside the garage attic that resulted in a pathway about 3 in. wide by about 18 ft long.

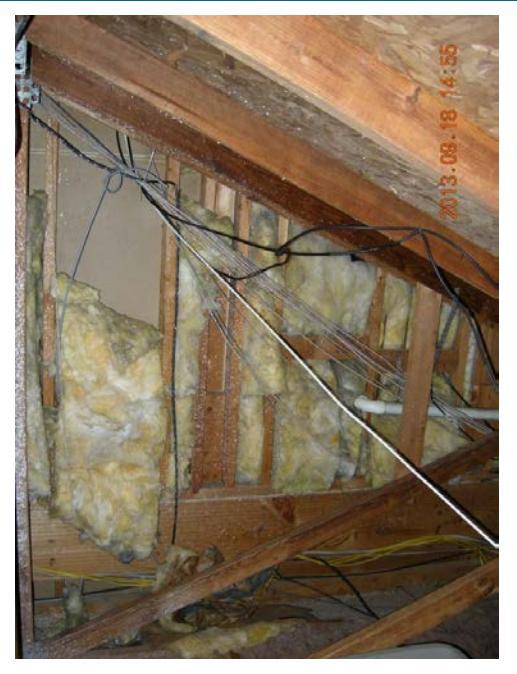
Figure A39. Garage knee wall with R-11 insulation in very poor condition. The irregular framing pattern and numerous wires make it more difficult to adequately insulate with fiberglass batts.
