Short-Term Test Results: Transitional Housing Energy Efficiency Retrofit in the Hot- Humid Climate

Karen Sutherland and Eric Martin
BA-PIRC/Florida Solar Energy Center

February 2013

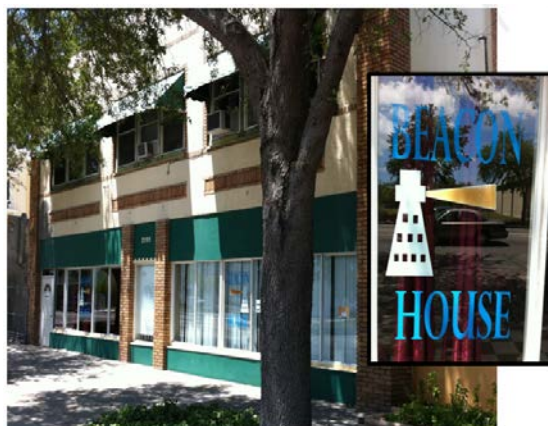
Figure 1. The Beacon House, transitional men’s housing shelter in St. Petersburg, Florida, built in 1926

Free Clinic Beacon House, hereafter referred to as the Beacon House (see Figure 1), is owned and operated by St. Petersburg Free Clinic, Inc.,¹ a multiuse facility that provides transitional shelter to homeless men. The shelter can sleep and feed up to 30 men and provides community evening meals for approximately 200 people every day. The facility also provides its residents with bathing, laundry, and dining accommodations. A large commercial kitchen allows for food storage and preparation for the community meal services.

Constructed in 1926, the concrete block, two-story building comprises approximately 5,800 ft² of conditioned and semiconditioned space with a flat, vented, gravel roof. The building’s kitchen is not conditioned or isolated from the rest of the building with an air/thermal barrier. The first floor houses an office, two bathrooms, a dining area, a serving area, a kitchen, a general assembly area, and a laundry room. The second floor consists of two offices, four semiprivate rooms, a large dormitory with 28 bunk beds, and two bathroom areas containing several sinks, toilets, and showers.

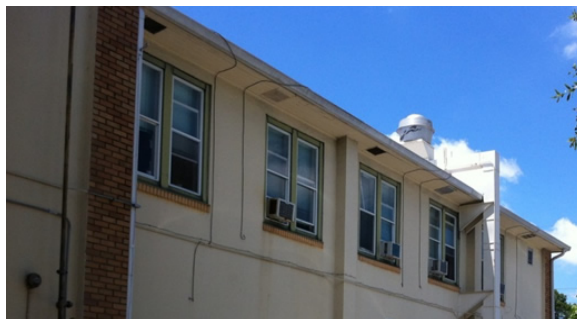
Figure 3. Eaves and vented attic of the Beacon House

Medium-colored tar and gravel covered the decking of the building's built-up flat roof, which had an estimated surface solar absorptance of 0.75. The vented attic with 2-ft eaves is presented in Figure 3. The attic depth and insulation value could not be visually inspected during the pre-retrofit energy audit because the attic was not accessible, and the scope of the low-level energy audit did not permit destructive investigation. It may have been possible to use a small scope or viewer, but the level of insulation was expected to be so variable that ascertaining an average would have been difficult. The location of the internal attic hatch was in a precarious place and external access would have required that the permanently affixed soffit be removed and a mechanism installed to elevate the auditor 20+ ft. Based on conversations with the contractor, an attic insulation R-value of 1 was used for modeling purposes.

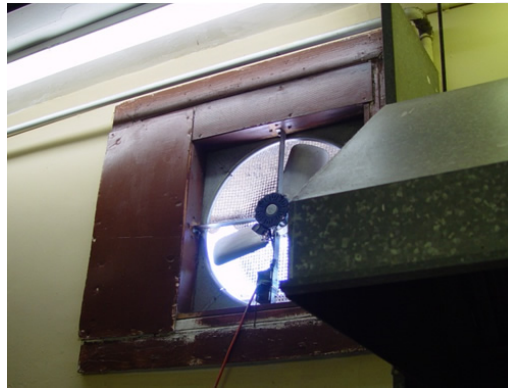
Figure 4. One of two through-the-wall exhaust fans ventilating the kitchen

A primary source of uncontrolled airflow into and out of the building was through the kitchen, which was ventilated by two built-in exhaust fans (Figure 4). Makeup air was provided by opening the kitchen's exterior door. Because the room was not isolated from the rest of the building, air from the conditioned portions of the building was exhausted through the open kitchen door and exhaust fans.

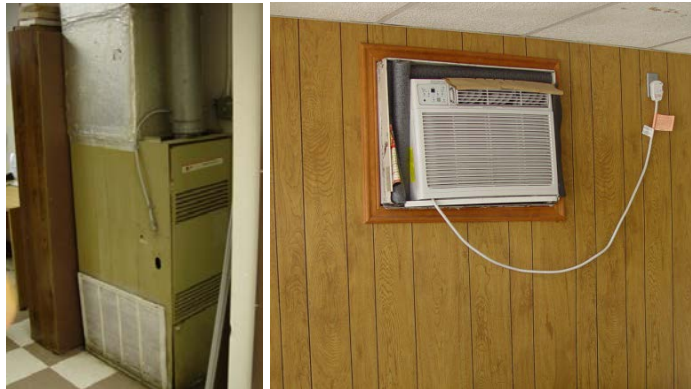
Figure 5. Natural gas furnace (left); window AC unit, fitted into rough opening with cardboard and foam (right)

Twenty-two window air conditioning (AC) systems of various operational conditions were used to cool the entire building. The unknown operational efficiencies were initially modeled to be a mix of energy efficiency ratios (EERs) 7 and 8. As Figure 5 shows, some AC units were poorly fitted, creating additional airflow pathways.

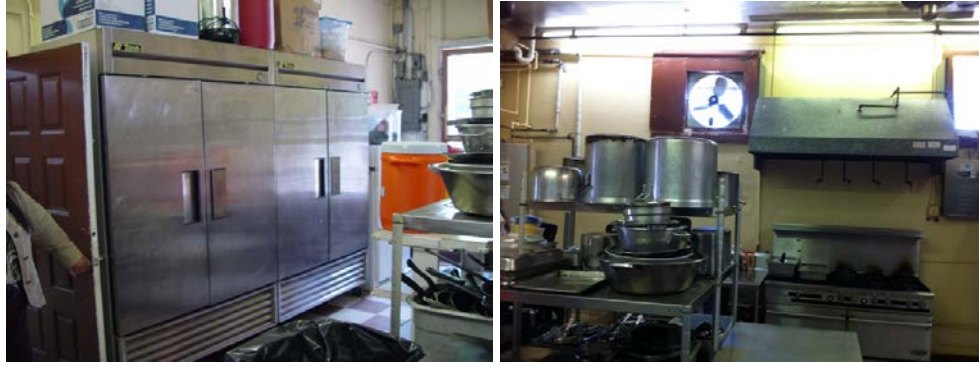
Figure 6. The commercial kitchen (refrigerators, left; range, right) feeds approximately 200 people each night

Multiple commercial-grade refrigerators (Figure 6) with internal compressor and condenser coils were necessary given the volume of food services. The eight-burner commercial gas stove (Figure 6) was accompanied by an outdoor-venting range hood. There were two sets of coin-operated washers and dryers, one older set and the other relatively new. Simulation software default efficiencies were assumed for both sets. The laundry appliances are available to occupants for personal use and were used twice weekly by facility staff for linens, towels, etc.

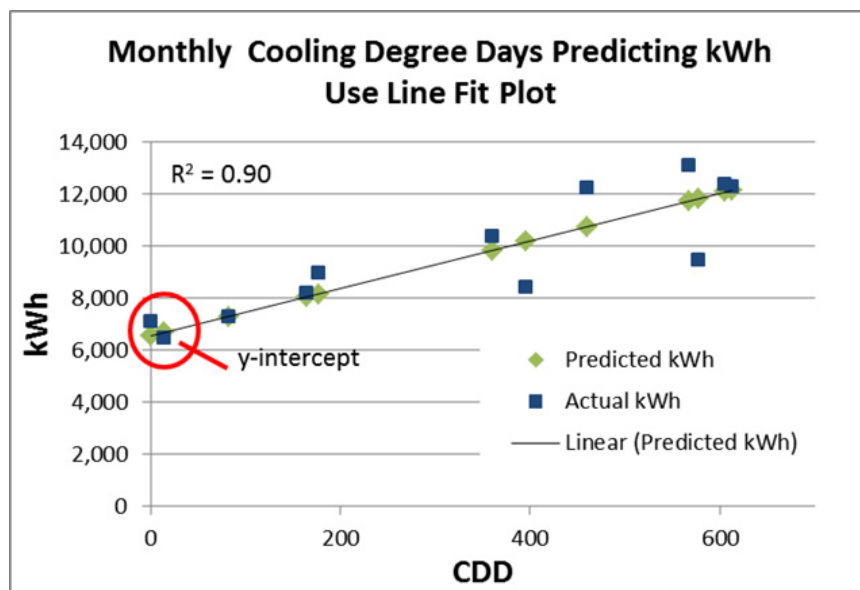
Figure 7. Actual and predicted electricity use by CDD. Y-intercept (base load) at 6,551 kWh.

Regression results were then used to predict monthly base load, cooling use, and heating use. The model's resulting line of best fit provides a y-intercept that represents base load: when CDD or HDD, and in turn cooling or heating energy use, is zero. Figures 7 and 8 are plots of the actual and predicted electricity use by CDD and gas use by HDD. For electricity, the constant monthly base load is where the trend line for the regression plot intercepts the y-axis, at 6,551 kWh. Use exceeding this threshold is associated with increased CDD and is interpreted as cooling load. The regression run with natural gas use produced a monthly base load of 65 therms.

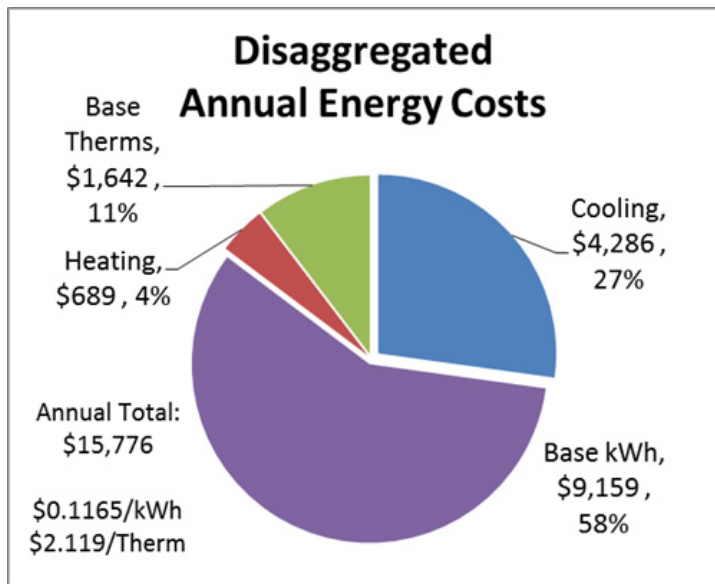
Figure 9. Utility costs disaggregated by heating, base therms, cooling, and base kWh

Once cooling and heating use was disaggregated from the base load, monthly use was predicted. Multiplying the independent variable (CDD or HDD) regression coefficient by the CDD or HDD value for each month produces monthly cooling and heating energy for the 2010–2011 utility bill period. Annual base load electricity and natural gas use are 12 times their respective base loads (y-intercept). Results for the annual total disaggregated energy costs are shown in Figure 9, using average Florida utility rates. The large proportion of base load electricity is noteworthy: 58% of annual utility costs and 71% of total electricity use.

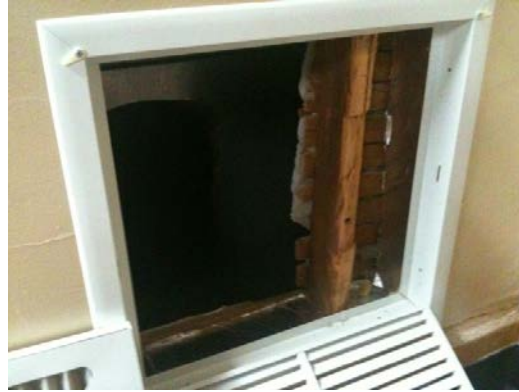
Figure 13. Post-retrofit, researchers observed an airflow pathway from a large open wall cavity between the AHU and the filter grille

During the whole-house depressurization test, researchers identified additional leakage sources—the edges of the attic hatch, around the interior kitchen doors where the weather stripping detail needed to be readdressed, and an open wall cavity in the second floor air handling unit (AHU) closet (Figure 13).

Post-retrofit duct leakage tests revealed the retrofitted duct system to be essentially devoid of leakage to the outside. The large penetration between the return plenum duct board and the wall cavity in the second-floor AHU closet was masked during duct testing (Figure 15). Matrix agreed to seal this access; however, masking this area for testing may have yielded better results than the eventual state. The first floor system duct leakage test results were $Q_{n,out} = 0.006$, and the second floor system test results were $Q_{n,out} = 0.03$. The combined results of the mechanical system change-outs and the duct retrofit yielded a significantly reduced duct leakage from the assumed pre-retrofit condition of $Q_{n,out} = 0.22$.

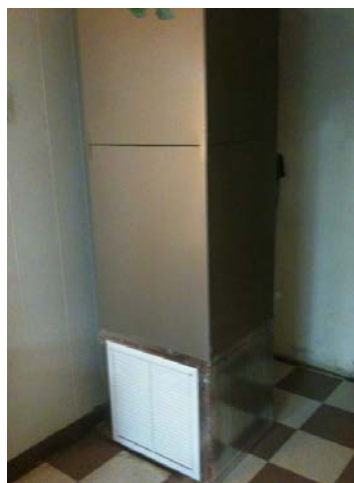
Figure 14. Post-retrofit ground floor, SEER 15 heat pump AHU

Two five-ton SEER 15 HSPF 8.7 forced air, central heat pumps replaced the 22 window AC units and two gas furnaces, as recommended. The Air Conditioning Contractors Association standardized Manual J sizing procedure considering post-retrofit specifications was used for heating and cooling load calculations. Programmable thermostats were installed for each system. The ground floor AHU is shown in Figure 14. Matrix reported a seamless installation, including the fuel change, which required capped gas lines. Electrical upgrades were essential to accommodate the electric resistance backup.

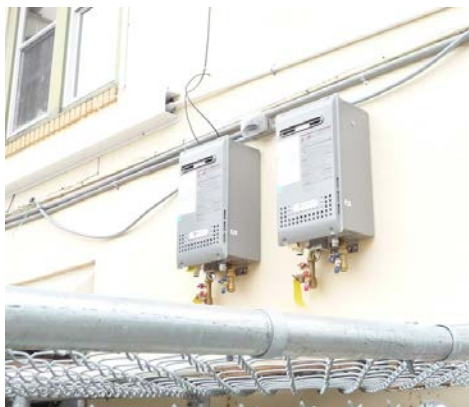
Figure 15. Two externally mounted gas tankless water heaters

Two externally mounted, natural gas water heaters (Figure 15) replaced the three electric tank units. This was an expensive retrofit measure because the gas piping servicing the building needed to be upgraded and water lines rerun to accommodate the new water heater locations. The EF for the new water heaters was 0.82, less efficient than the 0.90 recommendation. Matrix indicated the priority was finding equipment with the highest available capacity to accommodate the facility's large water heating demands.
