Are Residential Whole-House Mechanical Ventilation Systems Reliable Enough to Mandate Tight Homes?

FSEC-PF-469-16

2016 IAQ Conference

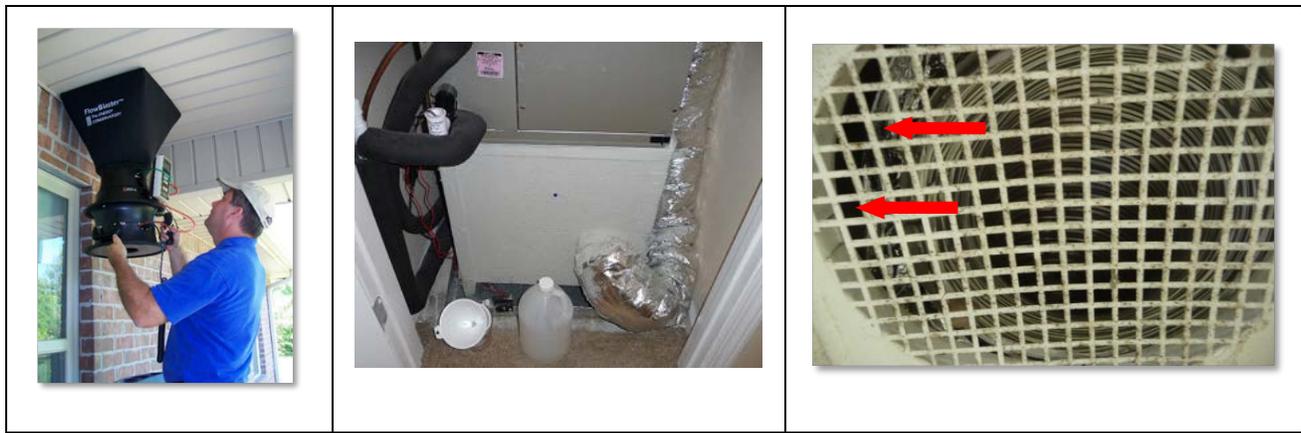
Figure 1. Study findings included: a) airflows often fell short of design values, b) outdoor air duct with hard kinked turn at plenum as shown, c) outdoor air intake duct disconnected from grille collar, resulting in over 40% of the “outdoor air” coming from the attic/soffit area.

Airflow measurements were typically taken at intake grilles located outside (see Figure 1a) and, if applicable, at outdoor air supply discharge or exhaust intakes located indoors. A fan-powered flow hood was the preferred instrument for measuring outdoor air flow rates due to its accuracy and ease of use. When airflow measurements had to be taken outside during windy conditions, the measurement period was prolonged. In some cases, airflow measurements were made by duct traverse method.

- Reduced air flow due to crushed or kinked ducts—at outside soffit or at return plenum (Figure 1b) (4)
- Outdoor air ducts slipping off of soffit intake grille collars -- likely due to very short collar height of about 1 inch at the intake grille and installation difficulty at restricted wall edge/roof junction space, causing outdoor air to be drawn from soffit/attic as shown in Figure 1c (2)
- Difficult access to ventilation system control located in attic (1)
- Uninsulated outdoor air duct in unconditioned attic (2)
- Rooftop air intake terminations where residents may not be aware of location and air may be hotter (3)
- Second floor soffit or wall intakes-- requiring a tall ladder to measure or service (8).

There were two cases where significant air leakage occurred at outdoor air duct terminal connections in unconditioned space. An example of this can be seen in Figure 1c where an outdoor air duct has partially slipped off an intake grille collar. Collar connections within vented soffits have tight clearance with the roof deck requiring tight turns, putting additional mechanical stress on the duct and connection. This highlights the importance of adequate collar height, good mechanical fastening, and secure sealing.

- Requiring intake grille or other vent collar heights to be at least 2 inches, mechanically attached to grille or vents, with seams and joints sealed with mastic or other code approved duct sealant
