Infrared inspection of ceiling insulation identifies missing insulation

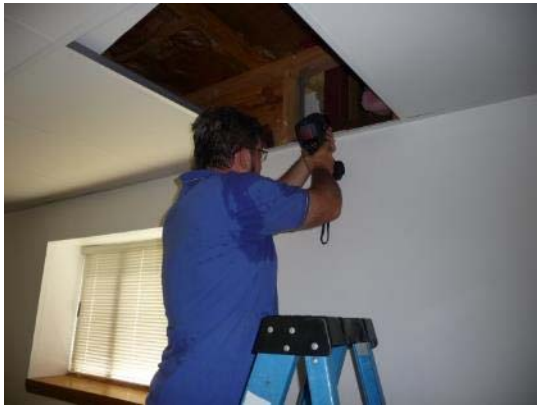
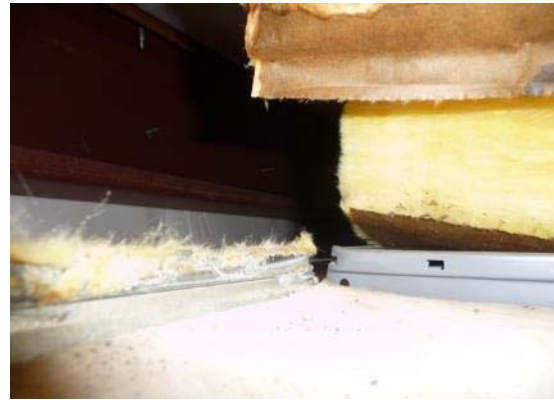
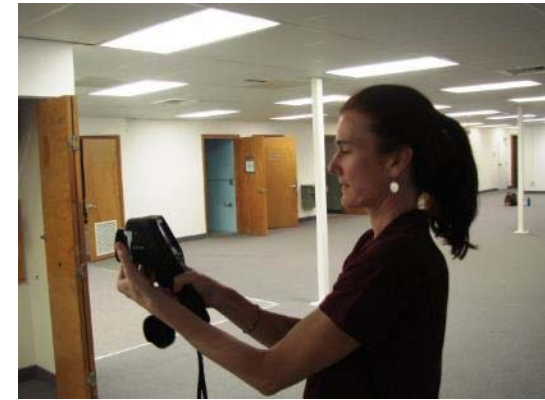
Above, inspection above ceiling tiles shows insulation (yellow) is patch instead of forming a continuous layer. The red areas on the infrared scan below indicate areas of high heat gain – where insulation is missing. Ceiling temperature at the cross hairs is 85.3 degrees – about 10 degrees higher than the desired room temperature.
