FLORIDA SOLAR

Energy Efficient Renovations of Storm Damaged Residences - Florida Case Studies

FSEC-CR-1648-06

September 8, 2006

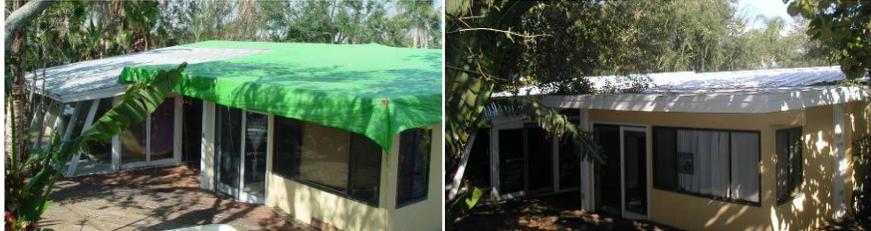
2.1 Home A

Predicted Annual Savings Against BA Benchmark	
Pre-retrofit	Post-retrofit
19%	29%

Most of the damage caused to the home during Hurricane Frances was due to failure of the roof covering subject to high winds, and subsequent rainwater intrusion. One flat roof section was stripped bare to the plywood decking, and there were a large amount of damaged and missing shingles. Extensive water stains were apparent on the ceiling drywall in every room when the homeowners regained access to the home after the storm. In two rooms, large holes eventually formed in the ceiling as the heavy, wet drywall failed under its own weight. A number of recessed can light fixtures and ceiling fans were also damaged due to the water. In addition, some of the water that leaked through the roof flowed down the trusses to where they meet the exterior concrete block walls, and flowed down behind the drywall where it pooled on the floor, ruining carpet and baseboards.

After an inspection by an insurance adjuster, the original plan was to replace the entire roof covering, any damaged roof decking, and to cut out and patch damaged areas of the ceiling and wall board. The long lead time encountered to get the roof replaced led to additional mold growth on the ceiling drywall. As a result, the owner decided to replace entire ceiling. Old blown in fiberglass and fiberglass batts were removed and the owner took advantage of this opportunity to converted the attic to an unvented type using BioBased foam. Rather than replace the roof covering with shingles that only have a life expectancy of 15-25 years, the owner decided to utilize white standing seam metal on pitched areas of the roof with a 50 year life expectancy. For the flat roof areas, rather than using a roll roofing, built up covering, or bituminous covering with a life expectancy of 5 years, the owner used a 10-year system that includes 1" of closed cell foam sprayed on the exterior of the flat roof decking which was then

covered by reflective silver colored, spray applied, coating to protect the foam from UV deterioration.

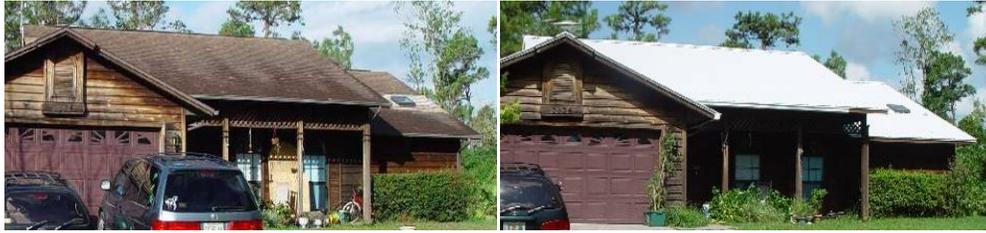
2.2 Home B

Predicted Annual Savings Against BA Benchmark	
Pre-retrofit	Post-retrofit
14%	19%

This 1,700 square foot home in Cocoa, Florida was damaged by hurricanes Frances and Jeanne. A white metal roof was chosen to replace the damaged shingles to reflect summer heat and thereby reduce cooling energy use. The shingles were not removed but left in place below the newly installed metal.

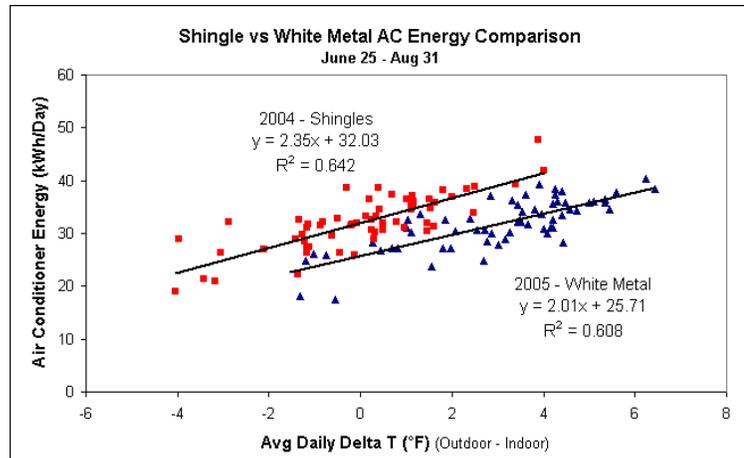
Figure 3 Shingle vs. White Metal

A nine-week period in the summer of 2005 show the white metal roof providing a 19% savings in air conditioner energy over the same period in 2004 when shingles were in place. Similar savings were seen in a more rigorous 2002 study comparing side-by-side homes in Ft. Myers, Florida. (Parker, Sonne, and Sherwin 2002)

Figure 3 shows the effect on cooling energy use by plotting daily air conditioner energy against the difference in indoor and outdoor temperature. This approach helps account for the difference in average outdoor temperature between 2004 (79.5°F) and 2005 (82.5°F).

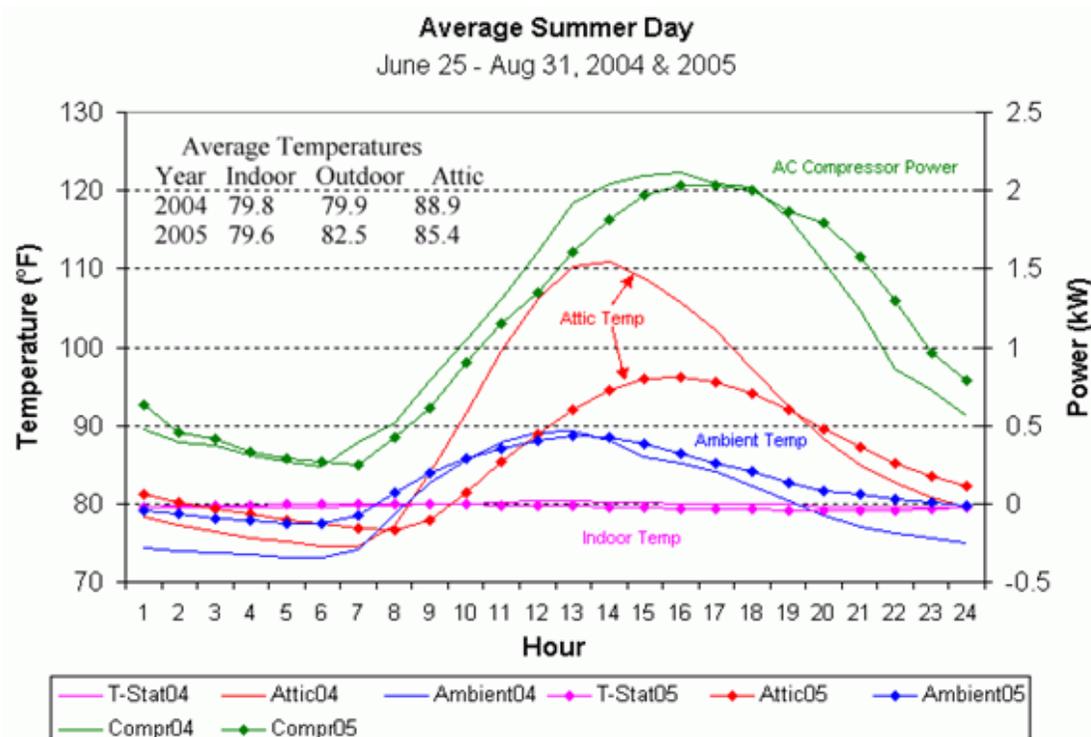
Figure 4 Average Summer Conditions

The average-day plot (figure 4) illustrates the effect of the white roof on attic temperature and cooling power. In this plot, average values of temperature and power for each hour over the 9-week data period result in an “average” 24 hour profile. The attic is noticeably cooler under the white metal roof (15°F at peak) during the day but is actually warmer at night, due to the warmer nighttime temperatures in 2005.

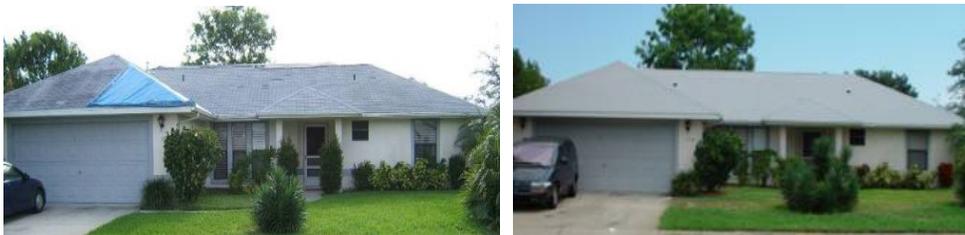
2.3 Home C

Predicted Annual Savings Against BA Benchmark	
Pre-retrofit	Post-retrofit
11%	12%

This 1,960 square foot home in Rockledge, Florida was the least damaged of the four houses chosen in this evaluation. There was loss of shingles, but only a small amount of water actually came through to the ceiling. The damage to the ceiling was slight and when allowed to dry, only needed to be repainted. The fiberglass insulation in the attic was not affected either. The replacement roof for this home was purchased and installed by the homeowner. The original dark, 3-tab asphalt shingles were removed and replaced with white ones.

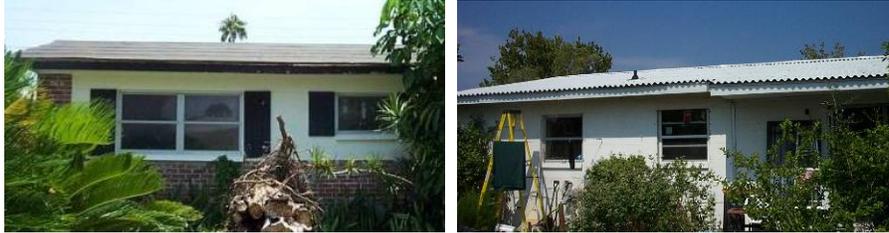
2.4 Home D

Predicted Annual Savings Against BA Benchmark	
Pre-retrofit	Post-retrofit
-7.5%	20%

This home was the most severely damaged of the four buildings in the analysis. A section of the rear portion of the roof was destroyed allowing water to enter into the dwelling which resulted in severe damage to the interior. As a result, the interior had to be completely demolished and rebuilt per recommendations. This retrofit included
