Investigating Solutions to Wind Washing Issues in Two-Story Florida Homes, Phase 2

FSEC-CR-2041-15

Final Report April 2015

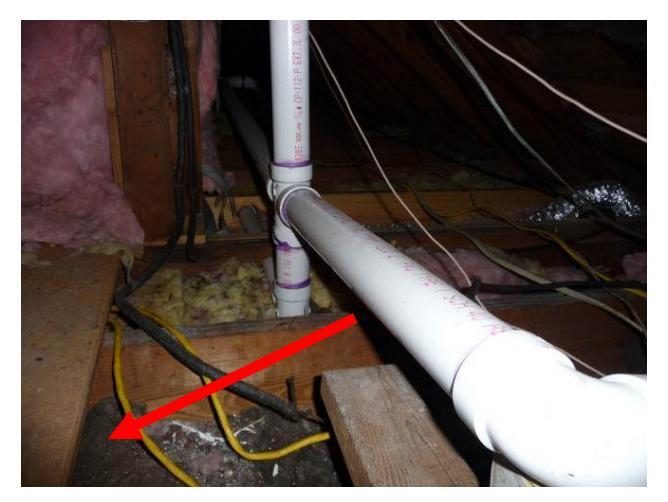
Figure 5. Photo from inside the east attic section at House H36M. The arrow points to the floor cavity opening. Attic vents are out of view on the right.

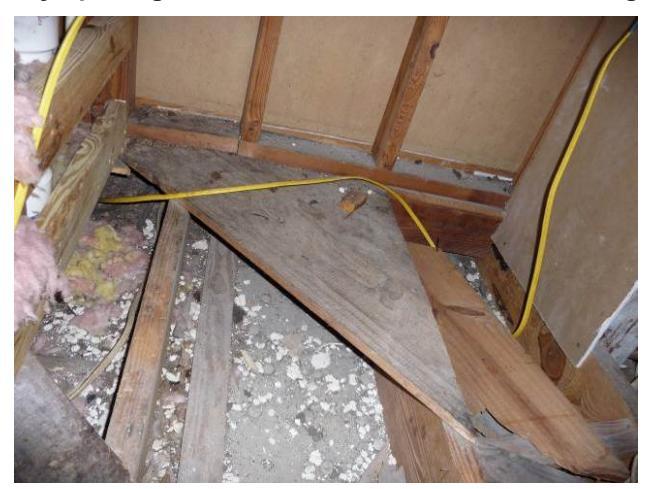
Figure 6. House H36M. View inside an east attic floor cavity section, with uninsulated knee wall area above. Complementary wind washing pathways are located at the other end of the floor cavity in the west attic.

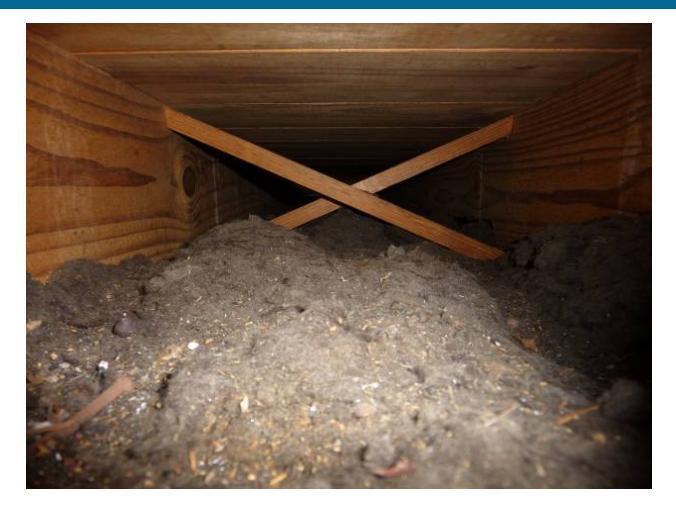
Figure 7. View inside one section of floor cavity from the east attic of House H36M. This floor cavity is wide open to the attic space.

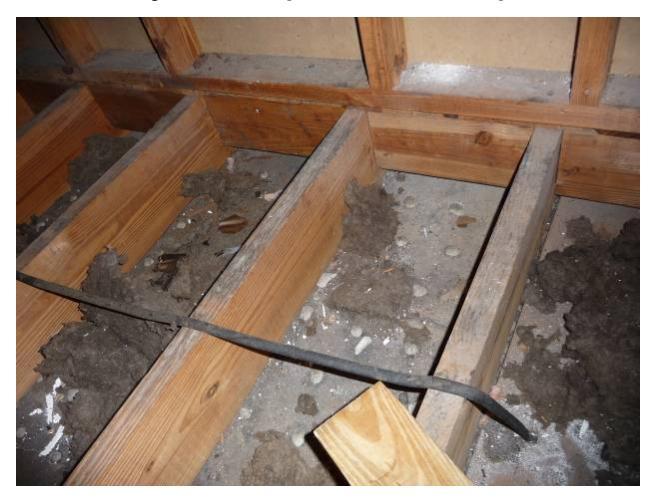
Figure 8. Most of the floor cavity openings from the west attic of House H36M are substantially blocked by frame members positioned between solid floor joists (see close-up in Figure 9).

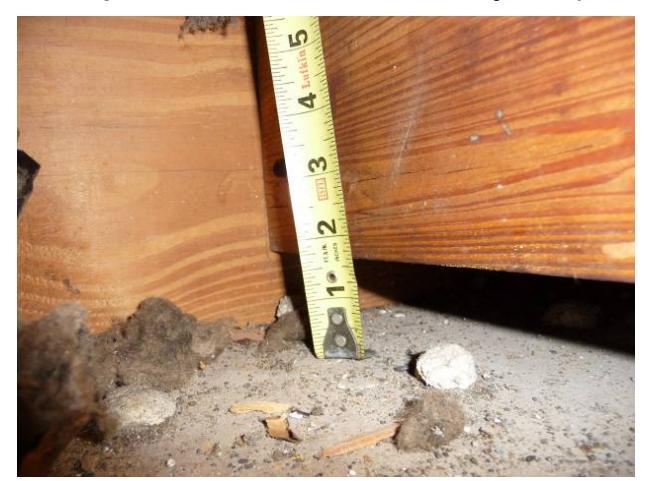
Figure 9. Most of the openings between the attic and floor cavities are blocked by frame members, leaving a 1-⁵/₈-in. gap that occurs continuously. Pieces of original dirty insulation (R-11) have fallen from the roof deck above.

Inspection of attic spaces revealed old, tattered, and filthy R-11 batts fastened to the wood roof deck. Pieces of batt insulation had broken down in some areas and fallen onto the attic floor below as seen in Figure A16. Attic vent openings seen in Figure A17 are more restrictive to wind-induced airflow into the attic space compared to a fully vented soffit. The total venting around the attic was just 1.9 ft² of net free area. If this home had a modern perforated vented soffit with a 1-ft overhang, the total free area of attic venting would be closer to 16 ft². Most of the second-story floor cavity had leak openings into both the east and west attic sections. The floor cavity is compartmentalized between solid wood joists 10 in. high and the pathways to attic varied from about 1-³/₄ in. to 10 in. high. The total accumulative open pathway areas to the west and east attics are 2.1 ft² and 10 ft², respectively. Photos of the nature of the air leak pathways in this home were shown earlier in Figures 5–9 of Section 3.2 of this report.

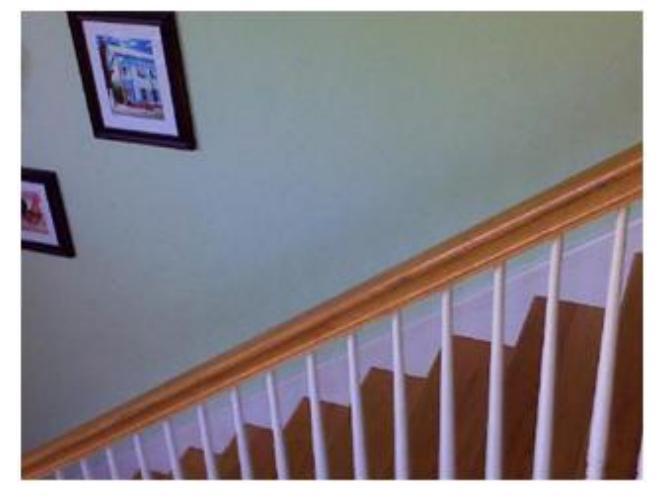
Figure 18. Winter IR image shows where cold outdoor air has penetrated into the floor cavity that lies behind the stairwell wall. The wall surface temperature at the floor cavity interface was 73.9°F, about 1.5°F colder than the room air temperature. Overnight low outdoor temperature was about 44°F several hours prior to the image with calm wind conditions.

Figure 19. Stairwell where the thermal anomalies occurred

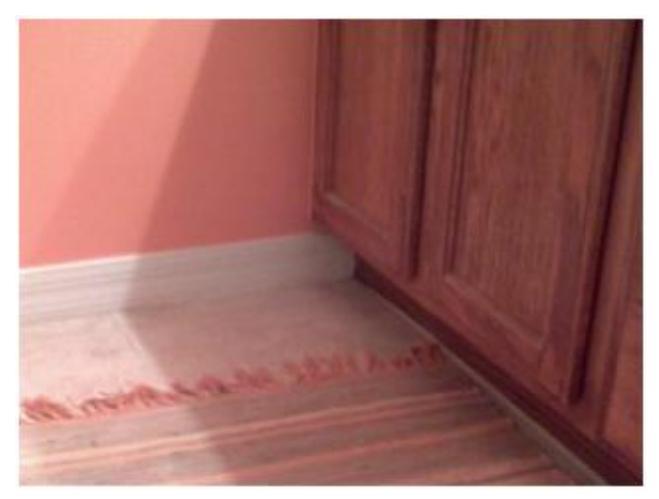
Figure 20. A bathroom floor had relatively cold surface temperatures compared to the heated area around it because of wind washing in the floor cavities below the floor.

Figure 21. Photo of bathroom floor

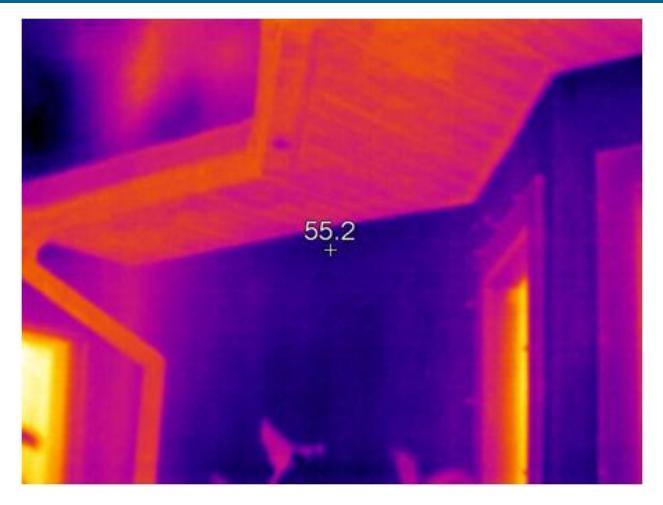
Figure 22. IR image of exterior west-facing wall. The soffit vent area is about 57.8°F.

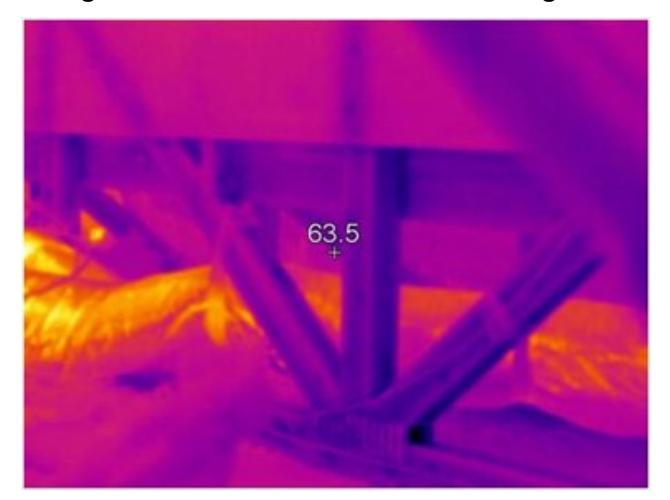
Figure 24. IR image of openings between the east attic and floor cavities near the second-floor bathroom

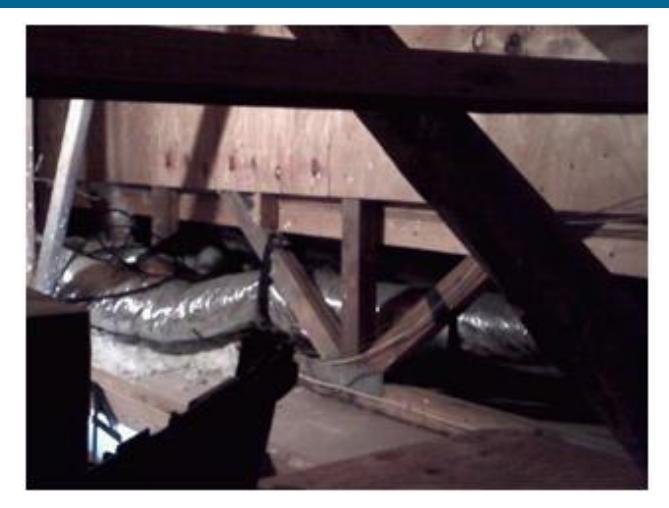
Figure 25. Photo of openings between the east attic and floor cavities near the second-floor bathroom

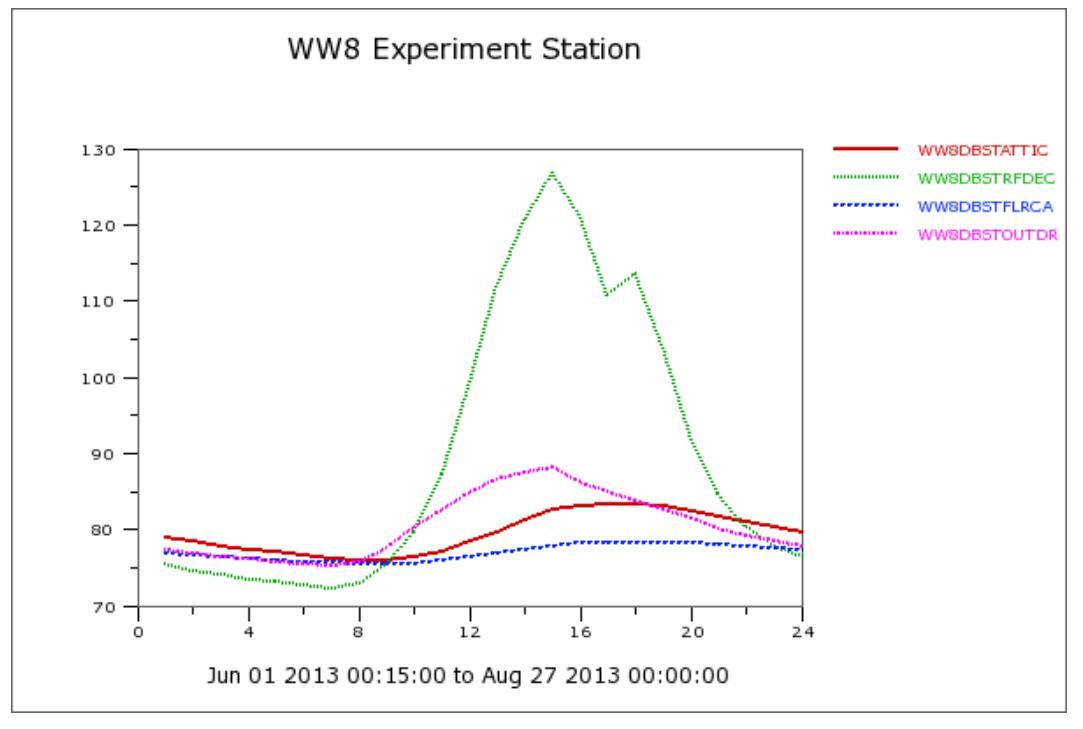
Figure 43 shows a composite plot of outdoor, attic, and floor cavity temperatures (°F) for all summer days from June 1 to August 27, 2013 for House H36S. This is during the pre-repair period. Red is the attic space temperature, green is the attic roof deck temperature between plywood and deck insulation, blue is inside the floor cavity, and pink is the outdoors. These data show that the peak temperatures in the lower attic area near the floor cavity averaged only about 83°F (5°F cooler than the peak outdoor temperature) even though the roof deck temperature peaked at 127°F. The post-repair profile is very similar to the pre-repair profile. The floor cavity temperature has a fairly flat profile and had a peak of only about 78°F, which does not suggest a large wind washing influence on average.

Figure 43. Pre-repair composite of attic and outdoor temperatures for House H36S

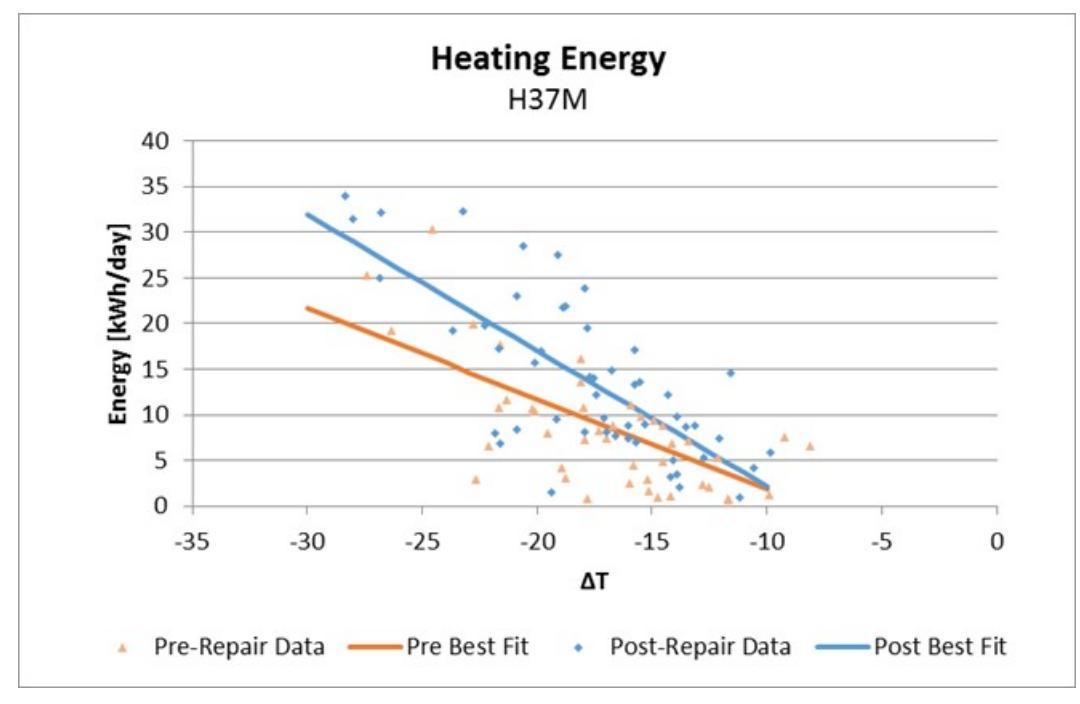
Figure 46. Daily heating energy and daily average dT between outside and inside for House H37M; the post-repair period was period higher because of equipment problem

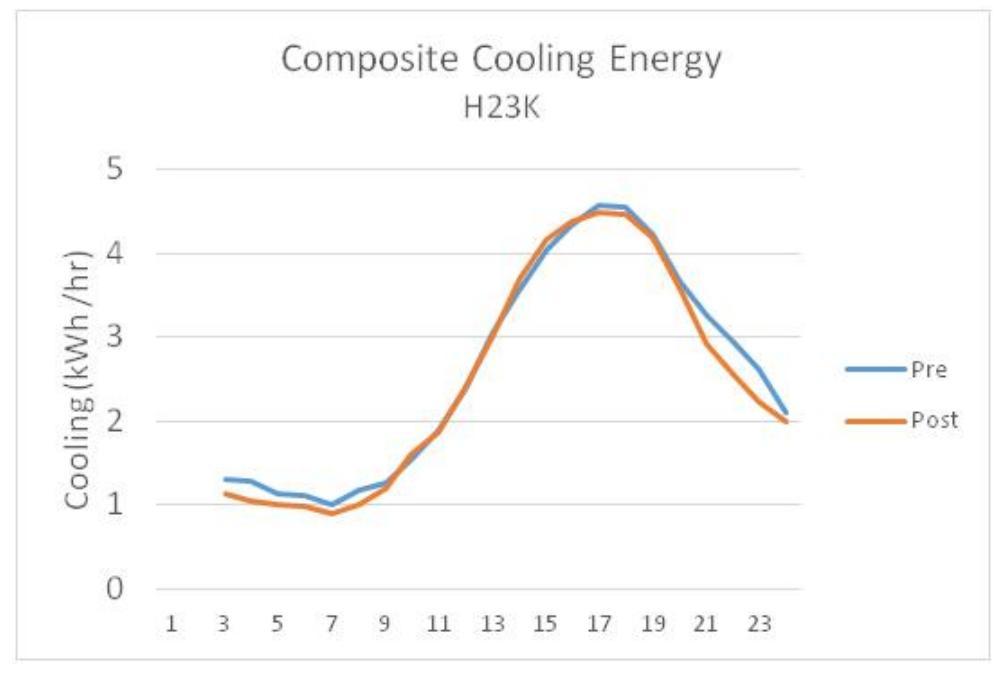
Figure 49. Cooling energy before and after repair of House H23K with hour of day shown on the x-axis

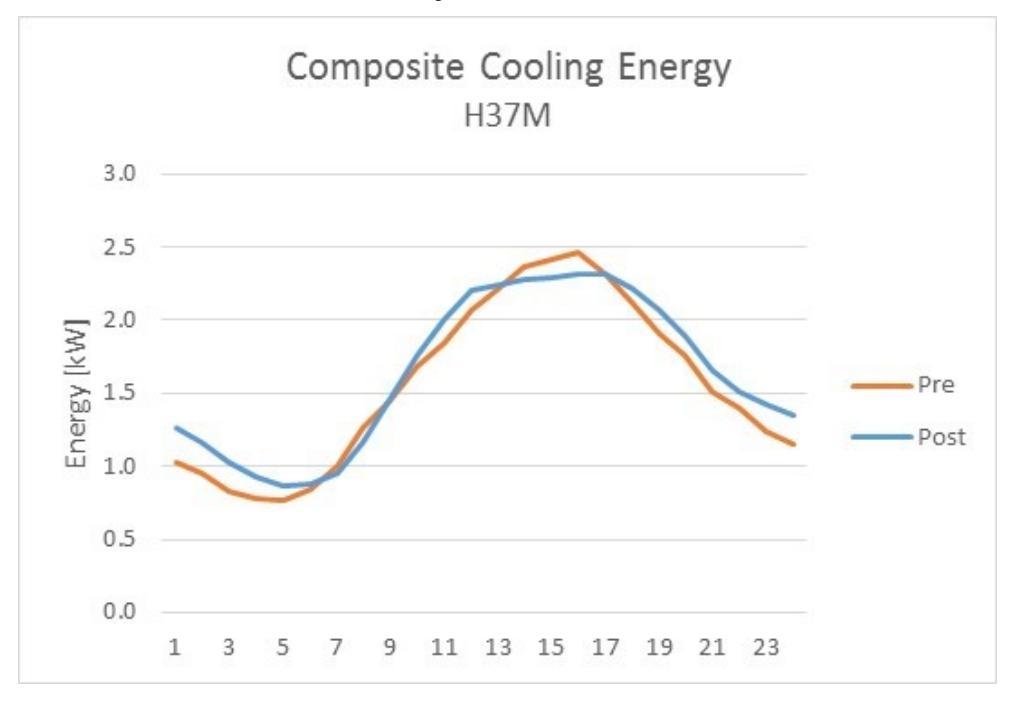
Figure 50. Cooling energy before and after repair of house H37M with hour of day shown on the x-axis

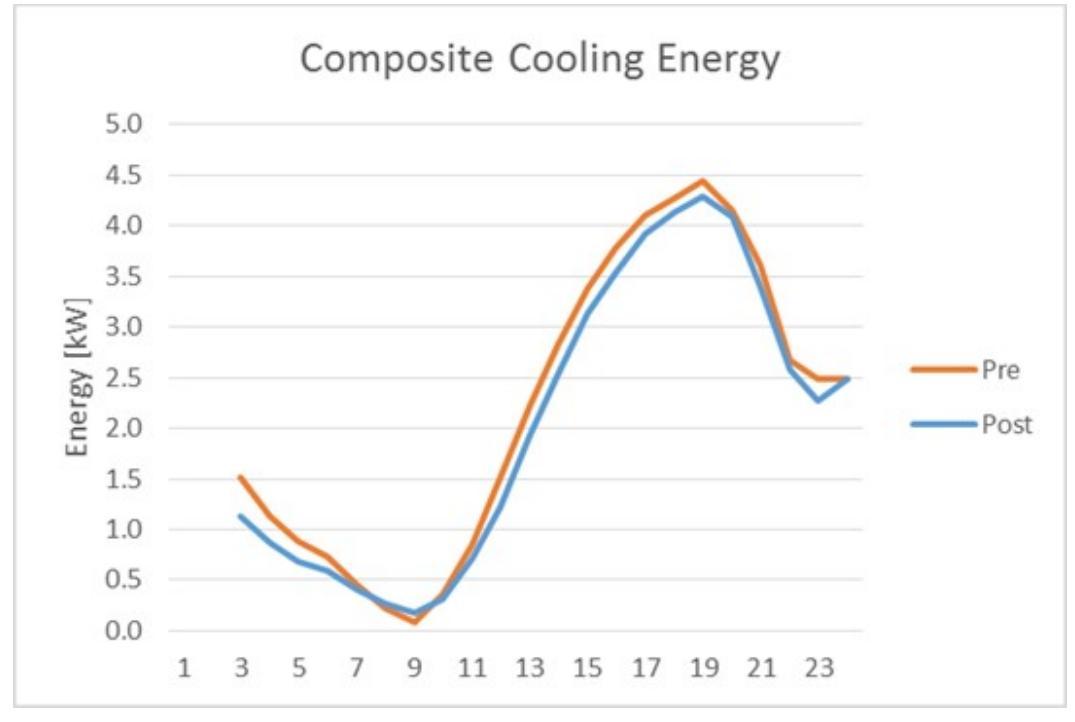
Figure 51. Cooling energy before and after repair of house H45H with hour of day shown on the x-axis

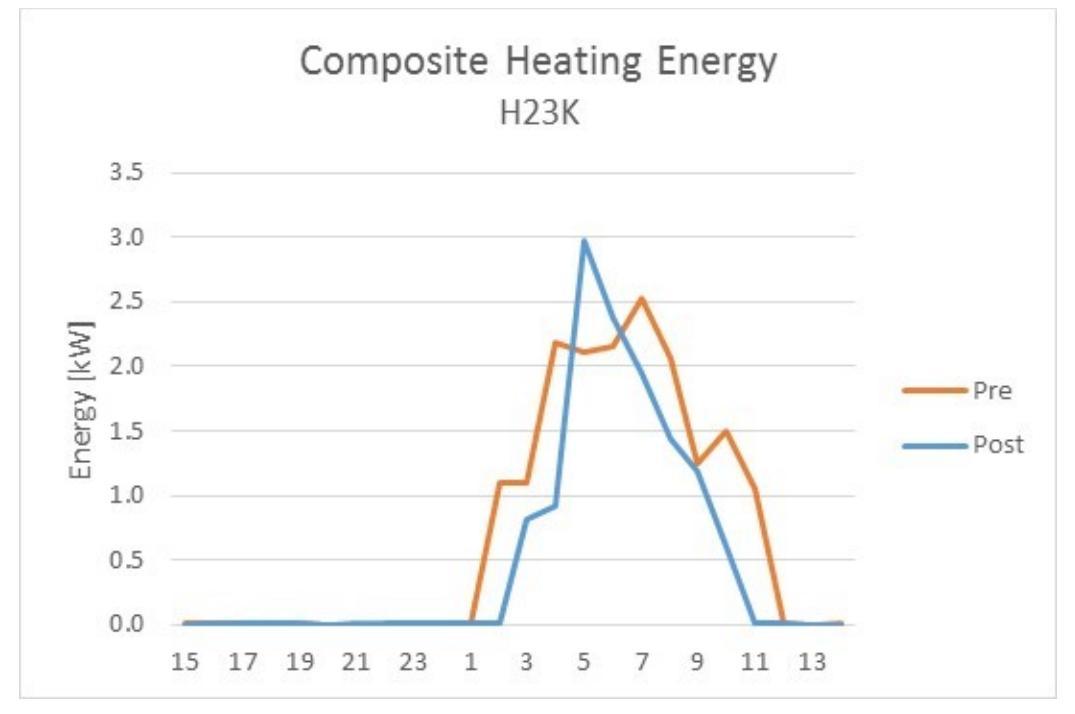
Figure 52. Heating energy before and after repair for House H23K with hour of day shown on the x-axis

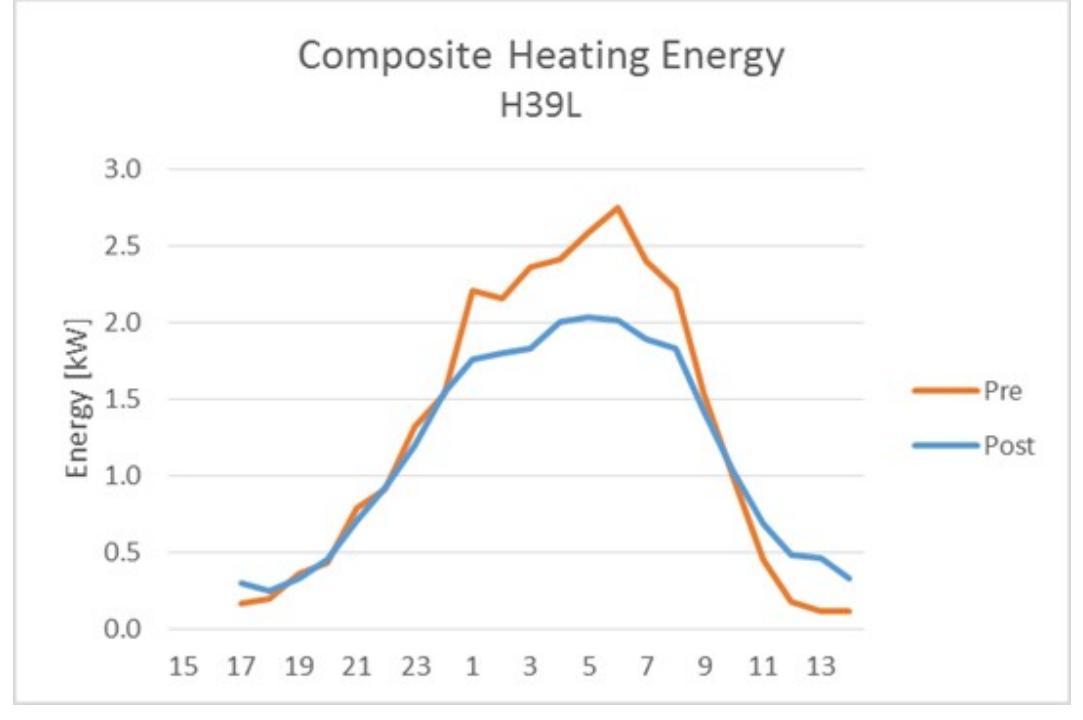
Figure 53. Heating energy before and after repair for house H39L with hour of day shown on the x-axis

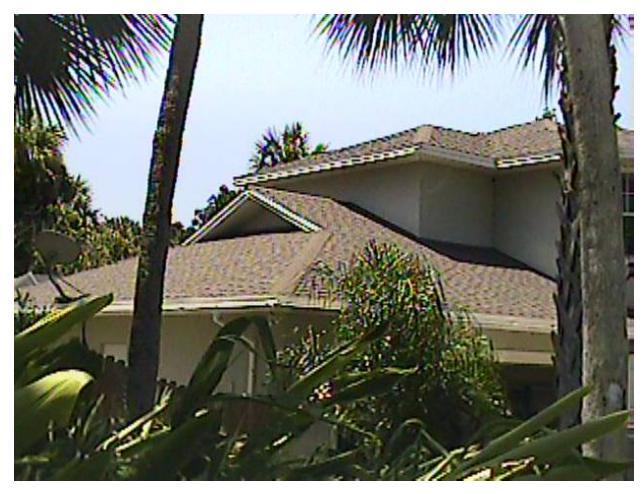
This house, known as H23K, was tested in August 2009 and was considered to have a high wind washing potential. This home is located within a half mile of the Atlantic Ocean, has a vented attic, and had open floor cavities oriented east to west, which readily allowed the predominant east-to-west sea breeze to flow through these cavities. An exterior view of the attic section over the garage on the east side of home is shown in Figures A1 and A2.

Figure A1. East and north sides of House H23K with garage attic adjacent to open floor cavities

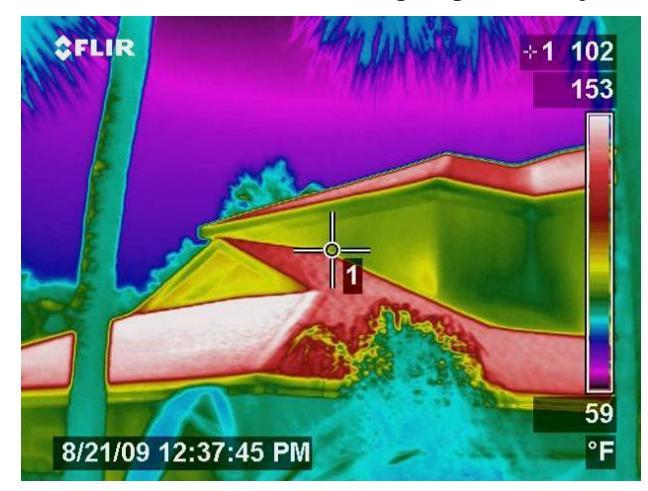
Figure A2. IR image of the house at midday after mostly sunny conditions all morning

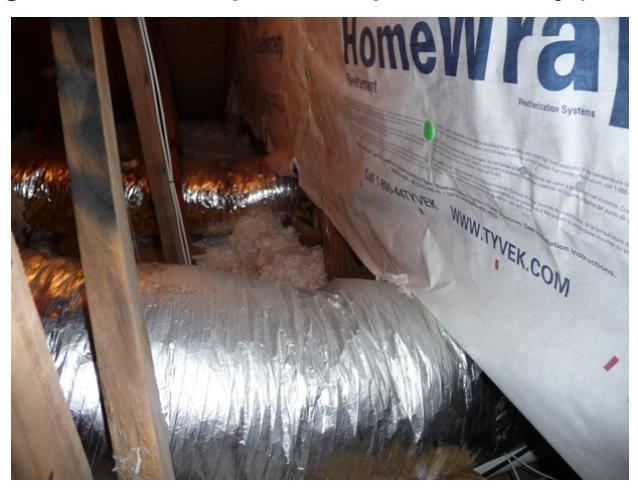
Figure A4. Looking at ducts passing from west attic into an open floor cavity

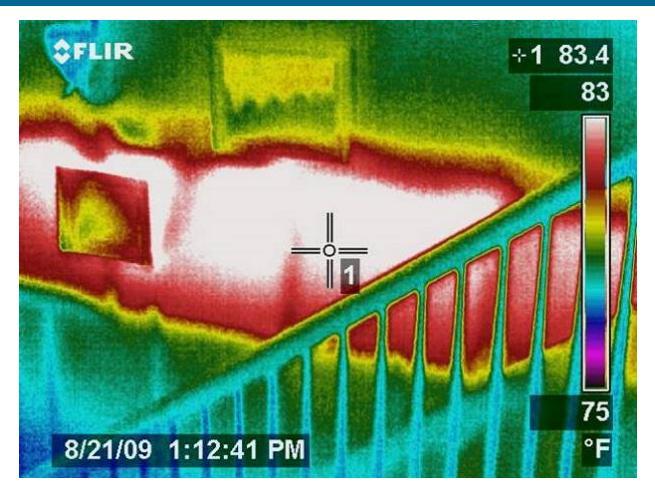
Figure A5. IR image shows where hot attic air has penetrated into the floor cavity that lies behind the stairwell wall.

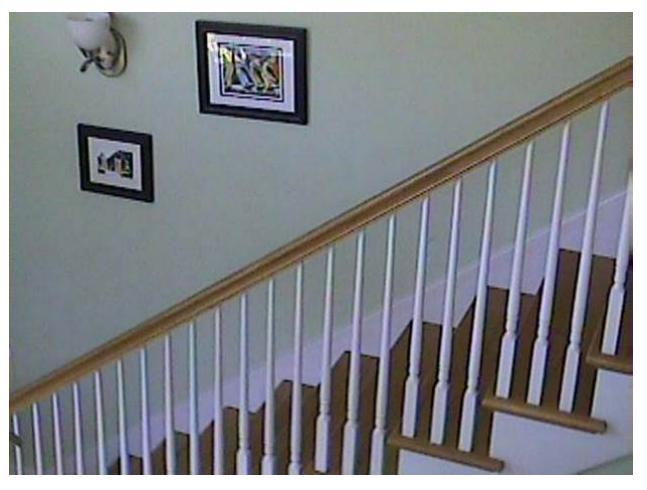
Figure A6. Stairwell where the wind washing thermal impacts is occurring

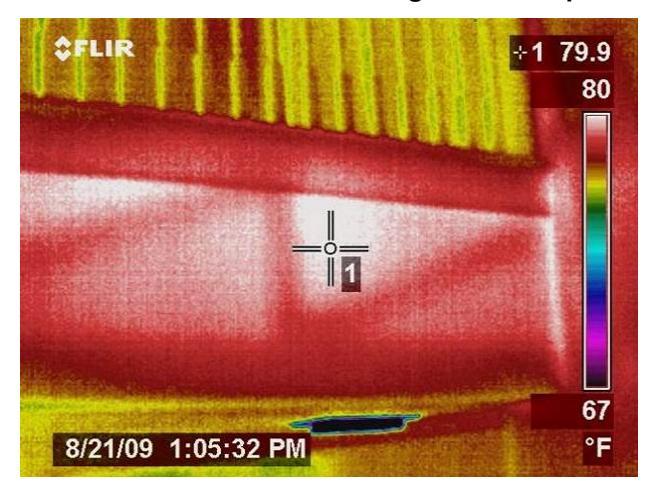
Figure A7. Thermal image of second floor landing. The heat signature indicates flow of attic air far into the interstitial cavities of the house.

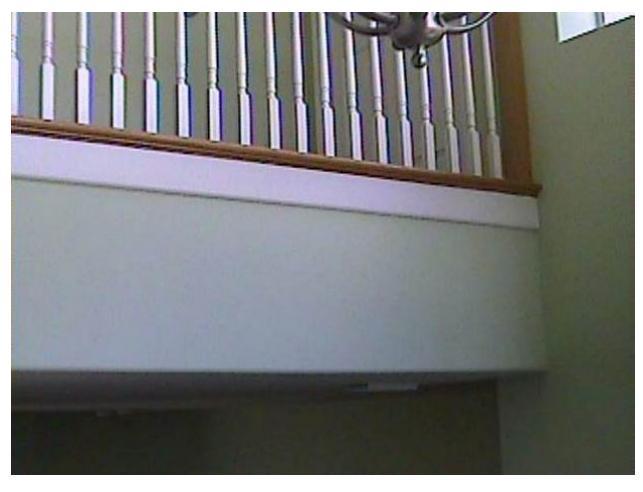
Figure A8. Photo of second-floor landing

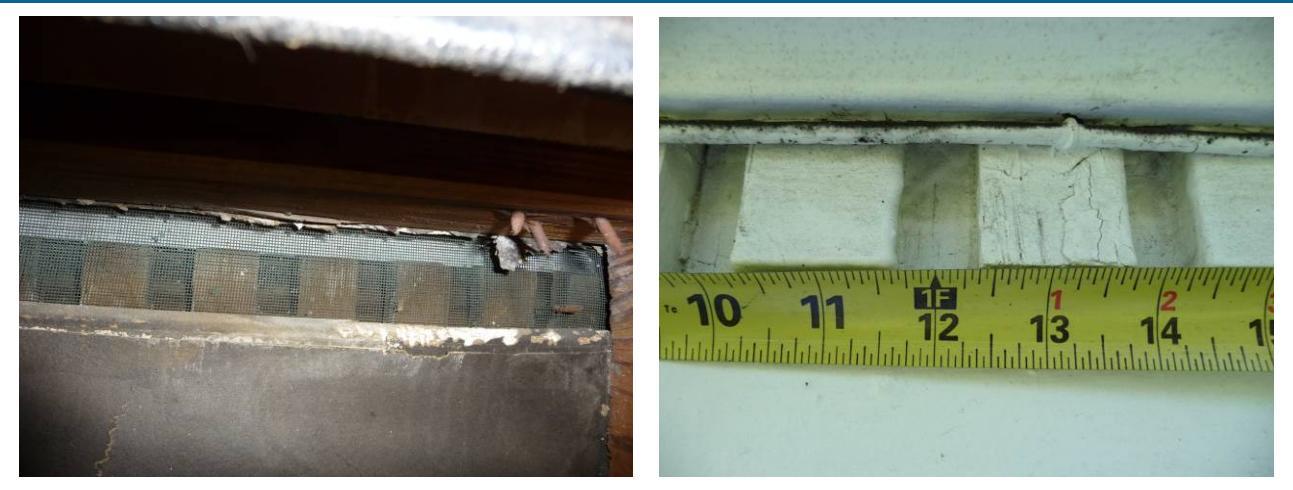
Figure A17. Dentil style attic venting viewed from inside attic and from outdoors. Venting is located along both east and west attic floor perimeters and has an insect screen on the attic side.

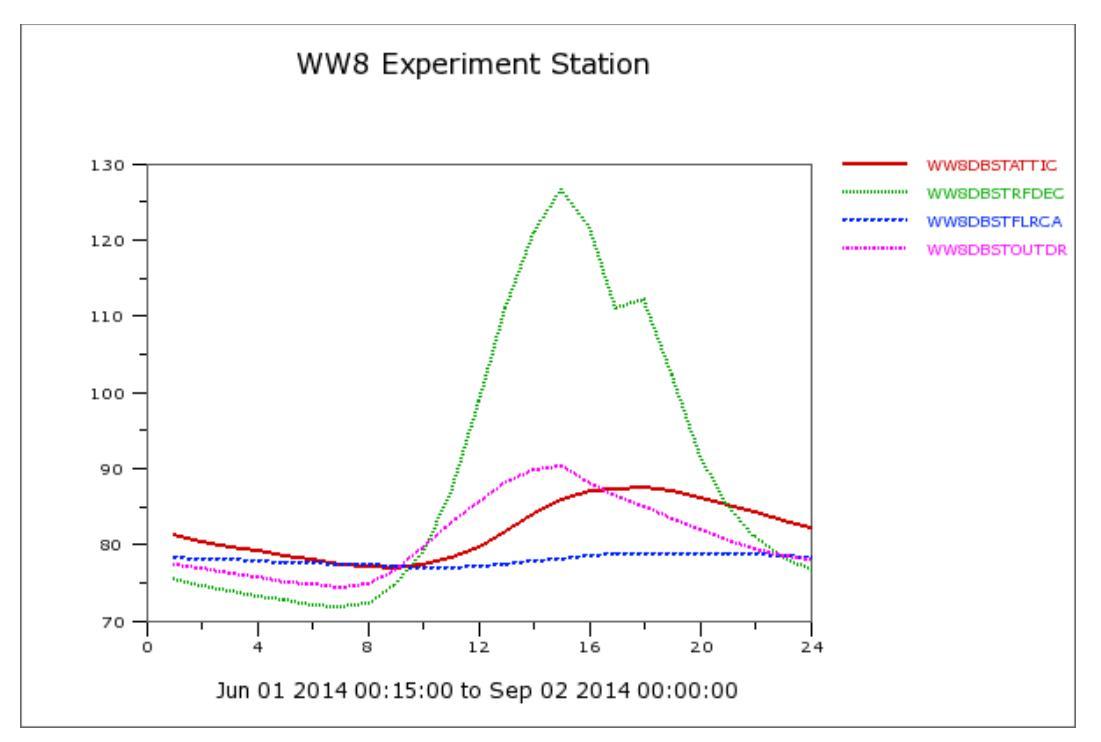
Original construction plans were available for this home. During the original construction, the primary thermal barrier was the R-11 batt insulation located at the roof deck just under an asbestos shingle roof. The roof deck insulation remained over the years and significantly limited the heat transfer into the attic during the summertime. Figure A19 shows a composite plot of outdoor, attic and floor cavity temperatures (°F) for all summer days from June 1 to September 1, 2014. This is during the post-repair period. Red is the attic space temperature, green is the attic roof deck temperature between the plywood and the deck insulation, blue is inside the floor cavity, and pink is the outdoors. These data show that the hottest temperatures in the lower attic

area near the floor cavity averaged only about 87°F (3°F cooler than the peak outdoor temperature), even though the roof deck temperature peaked at about 125°F. This post-repair profile is very similar to the pre-repair profile (shown previously in Figure 43). Even the floor cavity temperature was about the same, indicating very little driving force of attic air into the cavity.

Figure A19. Daily composite profile of outdoor and attic temperatures during the summer period

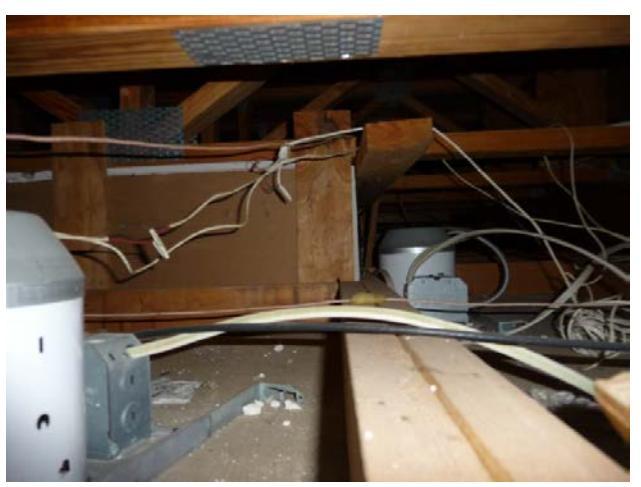
Because of its elevated location beside a nearby lake, this house has good exposure to winds from the south, east, and west. Inspection of attic space above the master bedroom on the west side of house revealed 0.3 ft² of openings between the second-story floor cavity and the attic. During inspection, strong northeasterly winds around 15 mph resulted in noticeable airflow through the floor cavity. A short video and photo image were made showing a piece of paper readily blowing from the second-story floor cavity into the west attic as a result of a strong northeasterly wind blowing into the east attic. Figure A26 shows the paper at the west leakage area around a duct penetration. Inspection of the east attic space above the garage revealed 9.2 ft² of openings between second-story floor cavity and the attic (Figure A27 and A28).

Figure A28. View from garage attic into the dropped kitchen ceiling with floor cavity above

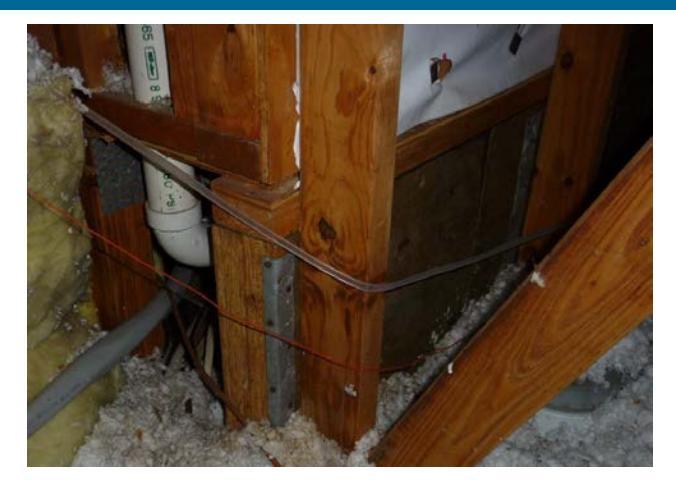
Figure A29. Corner of floor cavity with an air pathway around wire and plumbing penetration and a large area on the right side effectively blocked by plywood
