Flexible Residential Test Facility: Impact of Infiltration and Ventilation on Measured Heating Season Energy and Moisture Levels

R. Vieira, D. Parker, P. Fairey III, J. Sherwin, C. Withers, and D. Hoak *BA-PIRC*

September 2013

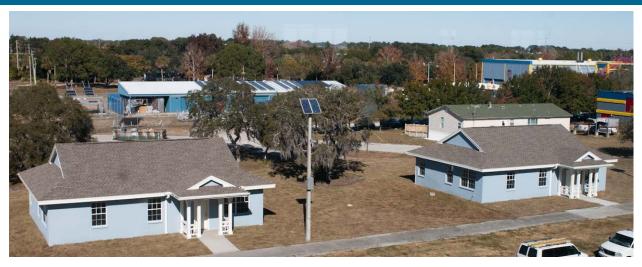
Figure 1. Completed flexible residential test structures on FSEC campus

Of particular significance to this report is the substantial effort that went into creating equal air leakiness in the 1,536 ft², 14,331 ft³ of volume buildings. Initial construction created reasonably tight buildings (3.62 and 3.82 ACH50), but FSEC staff further sealed leakage points until each was able to achieve 2.2 ACH50. The air distribution systems were tightened to achieve 13 CFM25/100 ft². (Qn = 0.013) in each home. Each home was then configured with controllable duct leakage and air leakage. The air leakage was designed to create the type of distribution and diffusion of air leakage represented in a number of southern slab-on-grade homes:

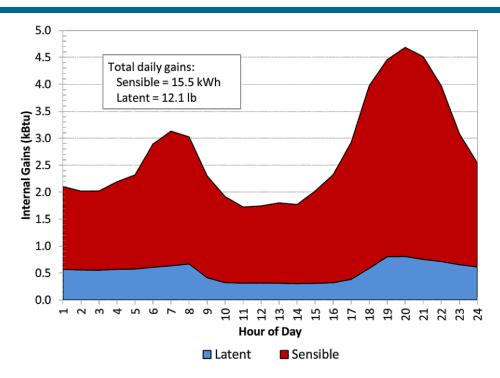
Figure 5. Daily load schedule for both homes

Due to the limited heating season in central Florida, internal gains can provide sufficient heat on some winter days, particularly in newer, tighter homes. Furthermore, internal moisture generation in a tight home without ventilation can create high moisture loads. The laboratories have automated (computer controlled) heat and moisture gains scheduled by time of day based on the Residential Energy Services Network lighting, appliance and miscellaneous energy usage amendment schedule (RESNET 2011, also see Parker et al. 2010). The hourly schedules utilized are shown in Figure 5, and more details of how they were derived and delivered are given in the report on the facility (Vieira and Sherwin 2012).

A second experiment was run whereby the latent loads were cut in half (6 lb/day), maintaining the same hourly profile but half the magnitude, in order to observe the effect on condensation and humidity levels.

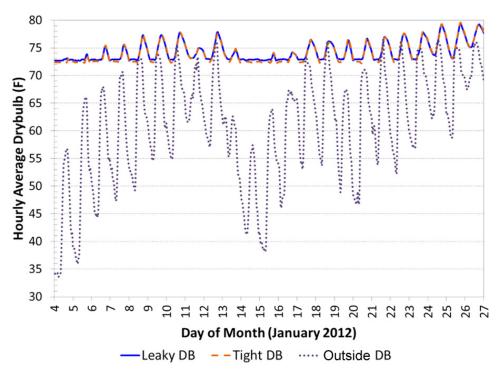
Figure 6. January outdoor and indoor temperatures

The average daily cycle (each hour averaged for the time period) is shown in Figure 6.

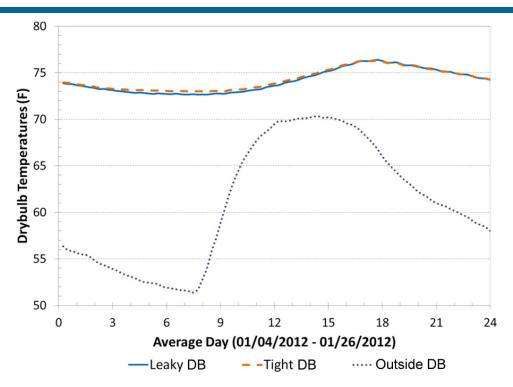
Figure 7. Twenty-four hour average cycle during January test period

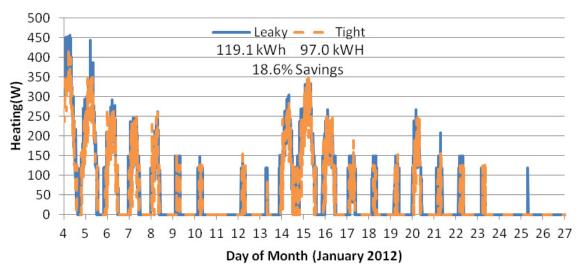
Figure 8. Comparison of leaky and tight home heating energy use for January 2012 by day of month

The heat was supplied by electric resistance furnaces. The energy use for each home for each day is shown in Figure 8, and the 24-hour cycle for the average day is shown in Figure 9. Due to the mild weather, there are some days without heating. Overall, there is about an 18.6% savings from the tighter home. Note that neither home has mechanical ventilation, and the result is based on a small amount of heating use. Also, there were some moisture concerns in the tight home.

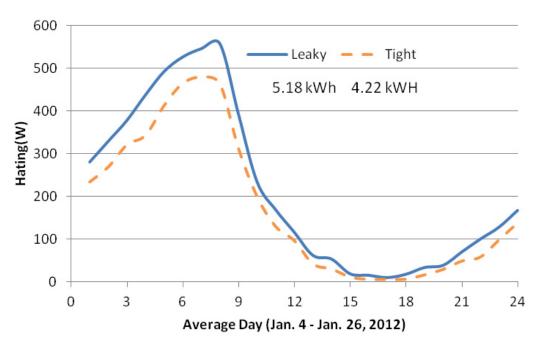
Figure 9. Average day heating energy use during January for leaky and tight homes

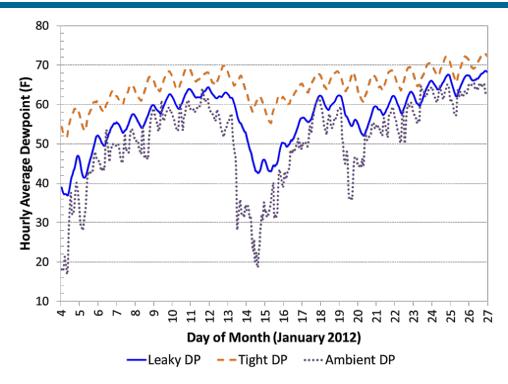
Figure 10. Dew points for tight and leaky homes for January 2012

Figure 10 plots the dew point inside each home and outdoors during January. Because of internal moisture generation, the moisture level in the homes is higher than outside. The leaky home dew point is $1^{\circ}-2^{\circ}F$ higher than outside typically, while the tight home dew point is $\geq 10^{\circ}F$ higher than outside. This resulted in significant hours when the dew point temperature inside the tight home was likely higher than the window temperature. Unfortunately, the laboratory did not have a thermocouple measuring window temperature (one is being added). However, the resulting condensation was significant during cold spells (see Figure 11 to Figure 16). The windows are single-pane, typical of most existing residential central Florida homes.

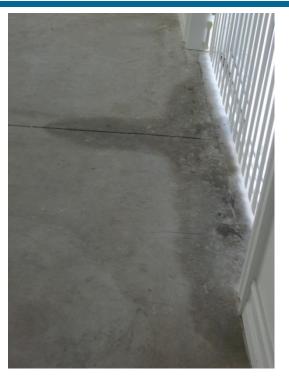
Figure 15. Tight home condensation residue by sliding glass doors

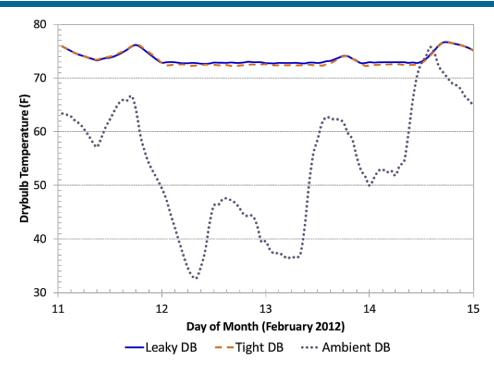
Figure 17. February outdoor dry bulb temperature during cold time period

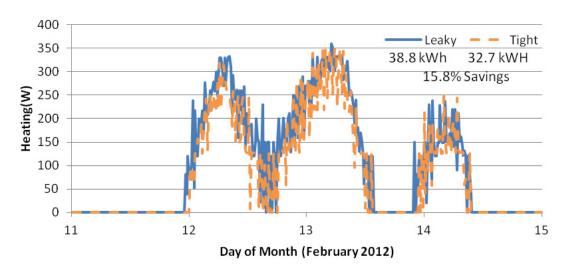
Figure 18. Heating energy use during February cold time period

The heating energy savings in the tight home were similar to the January tests but slightly less, with just 15.8% savings, as illustrated in Figure 18. The dew point temperatures inside the tight home were still considerably higher than in the leaky home (Figure 19). A peak difference between inside dew point and outside ambient of 19°F occurred during this cold spell (Figure 20). Condensation was observed during this cold spell even with the reduced moisture generation inside the home. However, the condensation was short-lived and did not create the mold as in earlier winter cold periods. Thermocouples were added to the glass and will be reported in future experiments.

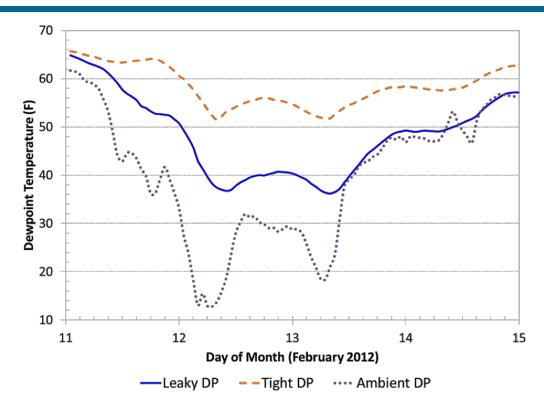
Figure 19. Dew point temperatures for February experiment

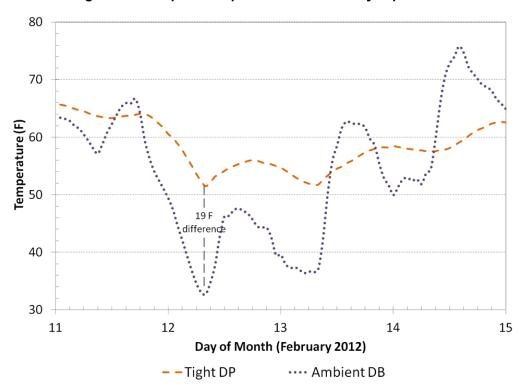
Figure 20. Tight house interior dew point temperature and outside dry bulb temperature. The large difference can lead to condensation on the interior of the single-pane windows.

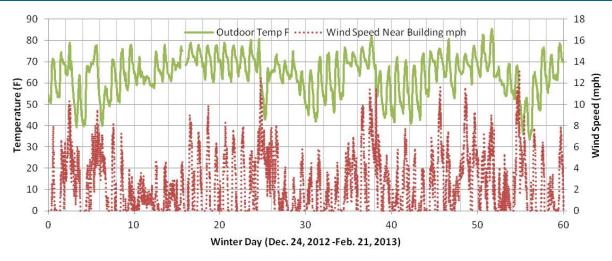
Figure 21. Ambient conditions winter 2012–2013

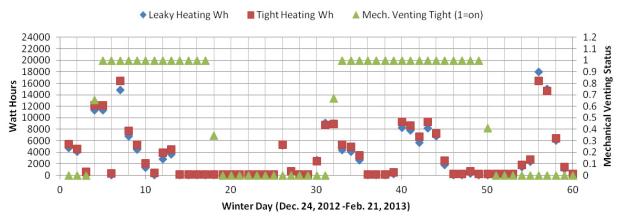
Figure 22. Heating energy use winter 2012–2013

The measured heating energy use consistently shows greater heating use in the ventilated unit when the ventilation is on. The results for when the ventilation system is off are not as clear during the two cold spells in 2012–2013 as they were in 2011–2012. To estimate savings from one house to the next, only days with 1,000 Wh of heating were included to eliminate any significant measurement error during low standby time. Days of ventilation transition were not included. This left 11 days of heating when the vent fan was off. The total heating used in the leaky unit those days was 70.205 kWh, and the tight unit used 70.398 kWh with no significant difference.

There were 16 days of significant heating when the homes were ventilated. The total heating used in the leaky unit those days was 95.6 kWh, and the tight ventilated unit used 110.2 kWh or a 15.3% increase in heating energy use in the tight ventilated home relative to the leaky home.

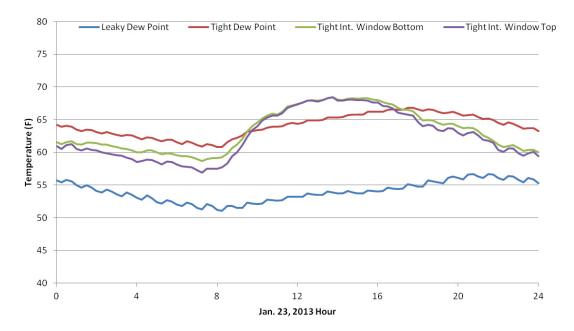
Figure 25. Unvented tight house dew point and window temperatures January 23, 2013

Dew point and window temperature data are shown for two such days, January 23 and February 17 in Figures 25 and 26. The dew point temperature in the tight west home is $\geq 10^{\circ}F$ higher than the leaky east home. The tight home window temperature is at times lower than the dew point leading to the observed condensation. Two interior window temperature measurements are shown from the same North-facing window, one from the lower portion of the single-hung window that was semi-protected by a window screen, and one from the upper half that did not have a screen.

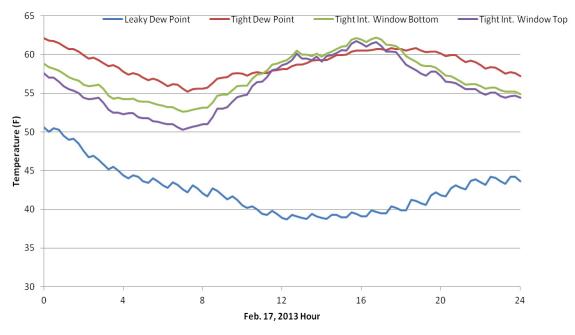
Figure 26. Unvented tight house dew point and window temperatures February 17, 2013
